Safety Alert

CCTV Camera Winch Failure

6 May 2020

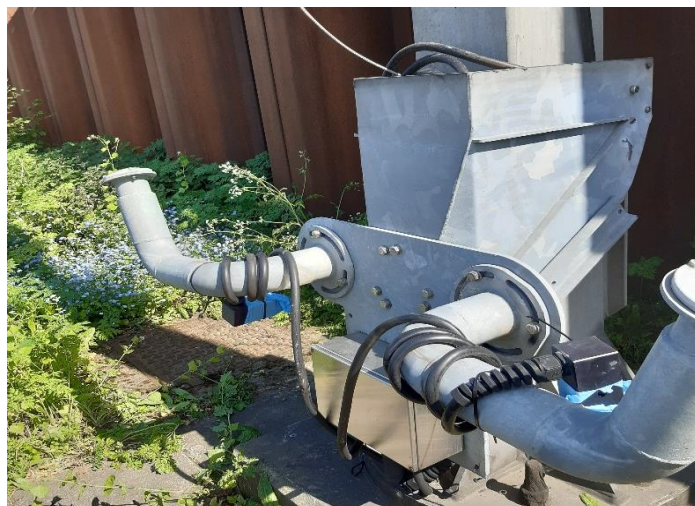
After changing the faulty camera, the carriage was raised back up the mast to the home position. At approximately 13 metres up the engineer noticed that there was an issue with the winching process and with the control cable, without prior warning the carriage was now descending.

The emergency braking mechanism did not activate. The camera carriage impacted at the base of the mast destroying both cameras sending debris flying. Both operatives were able to move clear of the base of the mast and were unharmed.

This is a WEC mast with a WEC winch, installed during 2012.

- Maintenance teams and inspectors should be aware of this concern and should appreciate the potential for **any** winch mechanism to fail:
 - Be aware of early warning signs, (for example, a jammed, kinked or frayed cable);
 - Do not rely on automatic braking systems for protection;
 - Monitor the progress of the lift or descent of the cradle at all times, and;
 - Be aware of the area covered by a falling cradle before commencing any ascent/descent operation.
- Do not operate any winching mechanism that has not been maintained in accordance with supplier's instructions or shows signs of not being properly maintained, or, is visibly damaged.
