Safety Alert

Damage to Underground Service

11 June 2020

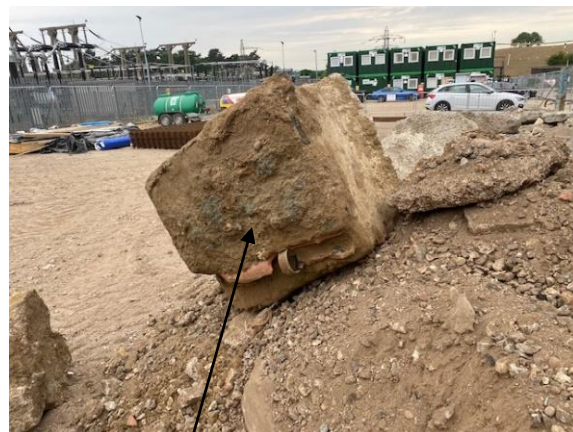
When lifting the concrete block, the watcher saw a clay duct stuck to the concrete, so they stopped the activity. The clay duct was embedded into the concrete. As the block was lifted the clay duct shattered, revealing the duct and its contents (5 cables).

To make the area safe the concrete block needed to continue to be moved. Once the block was safely removed it could be seen that there was damage to one of the cables (the outer sheath of a 15mm cable).

The approximate position of the concrete block is shown by the red outline on the picture to the right.

Drawings and CAT+Genny surveys are not a guarantee that all services have been identified.

Additional actions are required to prove an area is sterile of buried services (e.g. perimeter slit trench using safe digging methods)

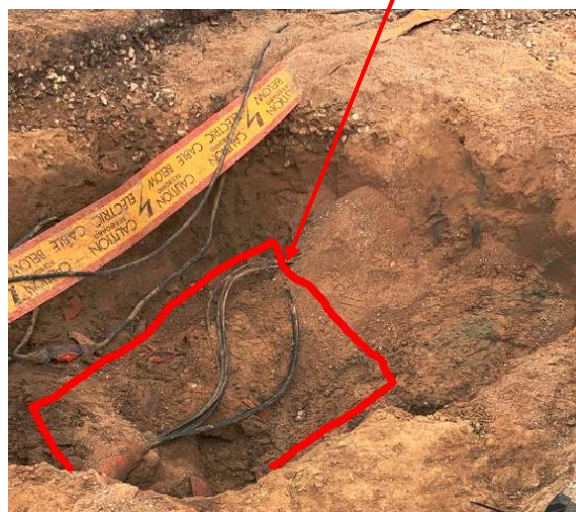
Concrete block (after removal)
Approx position prior to removal
