Safety Alert

HiPo: Asset Damage

SHE ALERT

Ref: SHE H166 A 2020

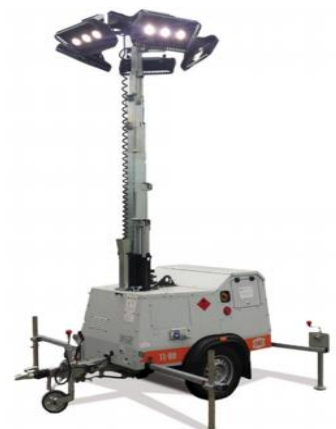
- The mast of the tower light was not lowered prior to transit.
- The mast was extended to approximately 5.5 metres
- The operative did not use the side primary controls for lowering the mast.
- The operative used the hand break (secondary control mechanism) to lower the mast.
- The hand break lowering mechanism was not fully engaged with the interlock system.
- The operative assumed the mast had lowered and did not complete checks prior to transit.
- The operative did not follow the manufacturers operating instructions.

Secondary control was not in full contact with the interlock.

- Ensure familiarisation training is completed prior to use.
- Follow the manufacturers operating instructions at all time.
- Tower light masts are to be fully retracted prior to transit.
- Carry out checks prior to transit.
