Safety Alert

Fractured ankle

SHE H175 A 2020
Issued by: Kier Highway SHE
Department
Date: 17/11/2020

Office Units Demobilisation Injury

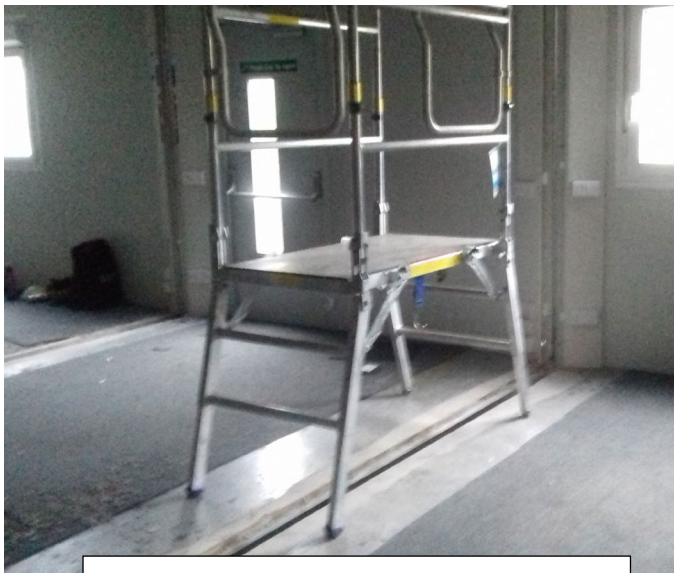
15.10.2020 a RIDDOR – Specified Injury incident occurred on the first floor of the former office building, M23 SMP Godstone Compound. The IP, who was working for subcontractor on behalf of modular building provider, was removing a ceiling cover trim standing on a delta platform which was positioned over the exposed floor gap. When stepping down from the platform the IP stepped into the exposed floor gap coming off the platform steps and twisted his ankle. Following an X-ray, the IP was diagnosed as having a fractured ankle.

Fig. 1 – position of the single person elevated delta deck, showing exposed gap between the two modular cabins

- A ceiling trim was overlooked during the removal of the internal trim.
- A review of the Safe Systems of Work it was found that there was a lack of planning & sequencing of works documented within the contractors RAMS referring to the internal strip out process of the modular buildings.
- The work zone where the former main office site had been handed over to the contractor to control during the decommissioning.

- Contractor review and revise their Safe System of Work detailing the sequence of works.
- Floor trims to remain in place until all ceiling work is completed.
- Supervisors to check work phases are completed fully before moving onto next.
- WAH Platforms should be placed away from any gaps or trip hazards.

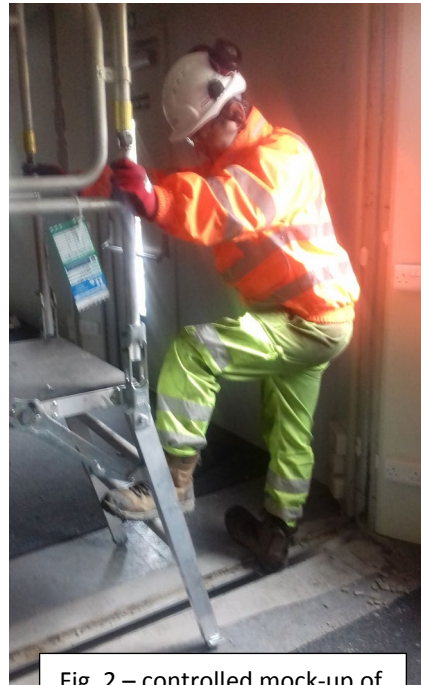
Fig. 2 – controlled mock-up of how the incident occurred.
