Safety Alert

**Failure of a sensor on an Impact Protection Vehicle
whilst working under a rolling road block**

11 February 2020

TITLE OF ALERT	Failure of a sensor on an Impact Protection Vehicle whilst working under a rolling road block		
TARGET AUDIENCE	Highways England and wider community	REF NO.	Amey TM 01/21
AUTHORISED BY	Craig Willsher	DATE ISSUED	10/02/2021

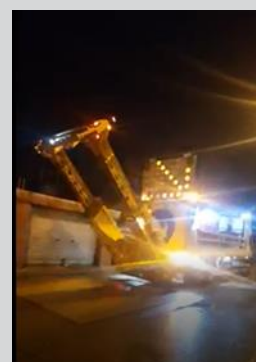
During the night shift on the 21st of January 2021 an incident occurred where a Verdigr Blade crash cushion fitted to a hired IPV, whilst being deployed, over extended whilst in the vertical position. In addition to the technical failure a potential hazard associated with overhead clearance had been introduced.

At the time of the failure the IPV was being used to install a taper in the All Lanes Running section of M6 motorway near junction 17 under a rolling road block.

- A sensor had failed, and the over extension had occurred in a manner that had never previously been seen.
- There was no secondary sensor, or any other preventative system installed by the Blade manufacturer Verdigr to prevent a failure of this nature.
- Blakedale considered the sensor failing was due to water ingress on the IP67 which is the standard sensor fitted to the majority of outside electrical components. IP67 is classed as waterproof although not against prolonged or high pressure streams of water, (e.g. pressure washers used for vehicle cleaning or severe weather)
- To reduce the possibility of water ingress Blakedale fitted higher rated IP69 sensors as the secondary sensor and will do so for all other sensors during the routine maintenance program for the Blade units. This modification has been extensively tested with no repeat of the fault occurring

- To reduce the possibility of water ingress Blakedale fitted higher rated IP69 sensors as the secondary sensor and will do so for all other sensors during the routine maintenance program for the Blade.
- Blakedale immediately notified the manufacturer /UK distributor and all known UK suppliers/operators of the failure, and their cause.
