Safety Alert

Gantry sign fixings

19 March 2021

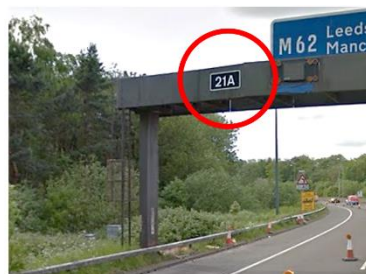
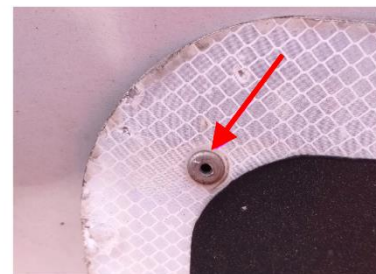
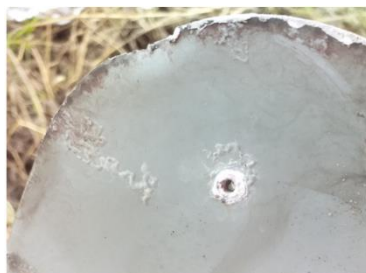
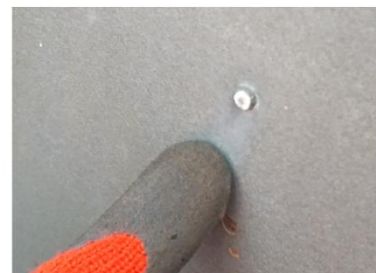
Records indicate the sign was installed approximately 25 years ago and was attached directly to the face of the steel box gantry by four, 4mm diameter, aluminium hollow rivets.

The failure appears to have been caused by bimetallic corrosion (accelerated corrosion due to contact between two dissimilar metals – in this case the aluminium rivets and steel gantry), exacerbated by the limited number of rivets and by not being able to inspect the part of the rivet where corrosion was taking place.

- Designers and Inspectors should be reminded of the risk of bimetallic corrosion and that corrosion of such fixings may not be immediately visible.
- Inspectors are urged to remain vigilant for similar details, particularly where there are a small number of fixings provided. Principal Inspections, which are undertaken within touching distance, give inspectors an opportunity to physically check for looseness.
- Existing gantries with signs riveted directly to their face should be reviewed and appropriate action taken to manage the risk posed by any similar suspect fixing arrangements.
