Safety Alert

Cracked / Failed Lantern Spigot

6 April 2021

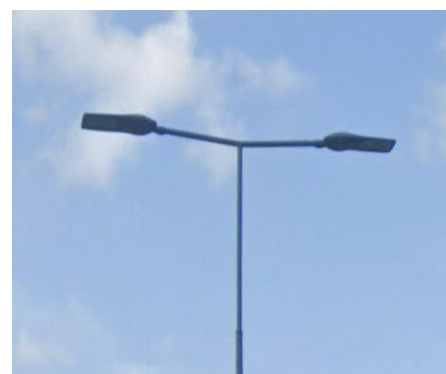
Twin head Lantern

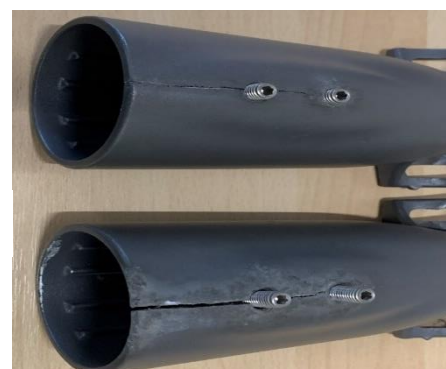
The lanterns had developed a crack in the spigot, between the two grub screws and running out to the end of the lantern. During installation the grub screws are tightened to a specified torque value and regularly checked during maintenance activities.

Crack aligned with Grub Screws

This alert highlights the importance of routine inspections, cyclic maintenance and checking the torque settings in accordance with manufacturers instructions.

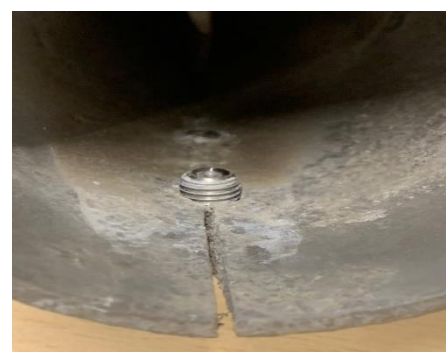
View on Crack / Grub Screws
