Safety Alert

Failure of a Precast Concrete Coping on a Bridge Deck

19 April 2021

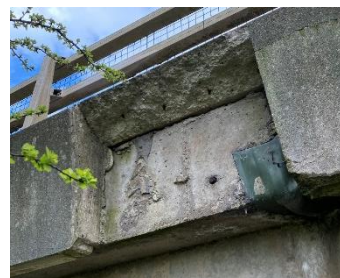
The failure appears to be a result of this joint in the precast coping units closing-up, restricting the movement of the deck and resulting in an increasing crushing pressure between the units. This has then caused cracking to the concrete in the precast concrete coping unit, followed by the lower section of the coping breaking away and falling to the ground.

Damaged Parapet Coping

- Inspectors should be vigilant and report any signs of restricted movement of the parapet edge beam, local to all bridge deck joints (both expansion and fixed end joints), particularly if precast copings are present.
- During inspections, any evidence of corrosion such as significant rust or water staining, or visual signs of movement of the coping, should be reported as defects.
- If cracking or movement is apparent in the 'throat' of any units, inspectors should consider further special / monitoring inspections, or removal of the copings.

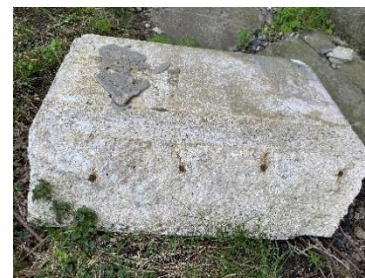
During a recent bridge inspection, a precast concrete coping was found to have become detached from the bridge above and fallen onto the verge.

Detached Parapet Coping
