Safety Alert

Portal Gantry – Loose Sign Support Connections

26 May 2021

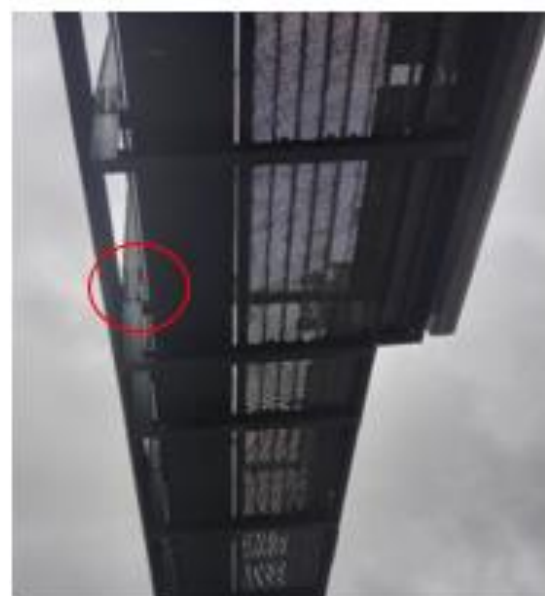
Following high winds, a Safety Inspection of a portal gantry sign identified the tall steel frame supporting traffic signs on top of a newly refurbished gantry, was rocking in the wind. A subsequent inspection identified the bolts in the splice connection had become loose and one bolt had fallen to the ground. Nobody was harmed.

Traffic sign support on portal gantry

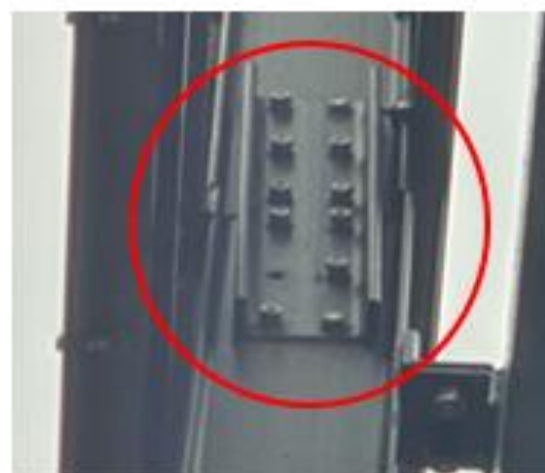
Close inspection identified the bolts were too short, with only limited engagement into the locking nuts designed to keep the connection secure. As a temporary measure the missing bolt has been replaced and all the bolts were re-tightened, until they can be replaced.

Missing/loose bolt, nut and lock nuts

Site bolted connections must be in accordance with the Designer's Construction / Fabrication Drawings. Bolts must be of sufficient length to allow for full engagement, with at least 1 full thread protruding beyond the outer face of the nut/lock nut following tightening.

Works Examiners supervising new works and Bridge Inspectors inspecting existing structures shall be vigilant and report for immediate action, similar defects with bolted connections, where the full engagement length has not been provided. If in any doubt please contact your local [SES Structures Advisor](mailto:Said.El-Belbol@highwaysengland.co.uk) for support.
