Safety Alert

Lorry driver Near Miss - Head stuck under tipper body

9 July 2021

Wainwright

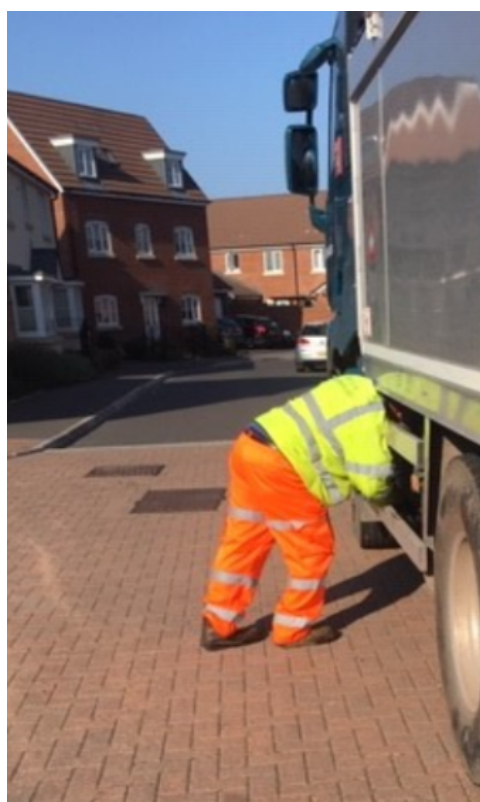
The lorry body design was such that an aluminium skirt around the bottom of the body sat approximately 6" from the side safety impact rail when the body was lowered.

As per the photo, when the driver leaned over the side rail to retrieve the scraper the body slowly came down and trapped him between the two surfaces and resulted in being unable to get his head out.

- A full investigation was completed in conjunction with the Haulage Company.
- The Haulage Company re-trained ALL drivers in relation to their Company Handbook - in particular, tipping procedures.
- The Haulage Company discussed the incident with the vehicle manufacturer to modify the locations / designs of skirts, toolboxes, controls, etc.
- Internal communications were made around all Hauliers within the Company.
- The driver was offered counselling.
