Safety Alert

Failure of Holding Down Bolts on Bridge Deck Expansion Joint

12 October 2021

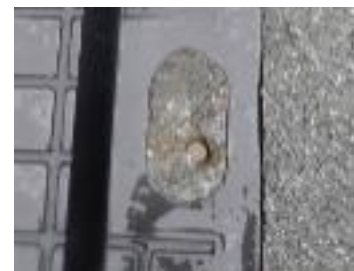
Two previous joint failures on similar joints identified the same concerns with the fixings relating to inadequate embedment / anchorage lengths of the bolts and lack of bond between the between the bolt and the resin that anchors into the fixing to the concrete deck. These defects required extensive remedial works.

Breakdown of bolt hole resin

- During routine Safety Inspections, Inspectors should be aware of this issue and lookout for protruding bolts.
- Any signs of deterioration, to the material surrounding the bolts at road level, should be picked-up during the principal inspections and flagged for action.
- The specification for all resin fixings for new Type 5 bridge expansion joint installations, to be checked and agreed with joint manufacturer, prior to installation.
- Records should be kept during installation of new joints to record the condition of the deck below the joint, the bolt embedment depths and any torque requirements for the fixing.
