Safety Alert

Pavement Coring using CAT and GENNY

21 February 2022

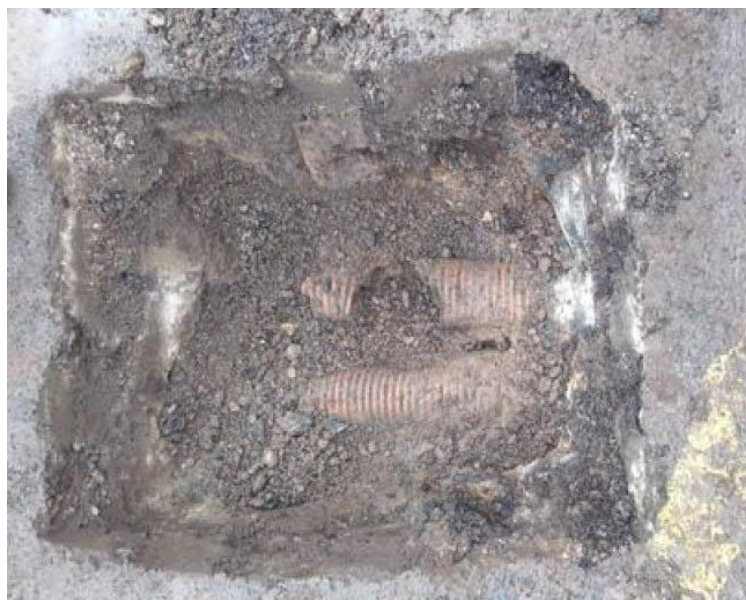
During a Pavement Coring and Dynamic Cone Penetrometer survey, three traffic light feeder cables cased within ducting, were severed whilst extracting the 150mm diameter pavement core.

After completion of the shift the permanent traffic signals could not be energised. Further investigation confirmed the core location was placed directly above the signal feeder cable and the cable was damaged during the coring operation.

- The data downloaded from the CAT4 Plus and GENNY showed the equipment had only been used in Power and Radio modes, both of which would not have detected the presence of the cables, as they had been de-energised.
- A thorough inspection of the area had not been carried out to identify potential service indicators, such as the service cover on the footpath.

- Ensure a GENNY is always used with the CAT and that scanning is undertaken in all modes.
- Ensure a thorough inspection of the area is undertaken to identify any potential services, such as scarring, service covers, street lighting etc. when undertaking the buried services assessment.
