# Safety Alert

## Overhead Cable Strike

## 11kV Utility Strike Driver Action

## 11kV Overhead Cable Strike

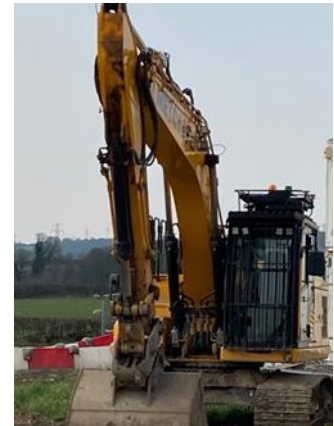
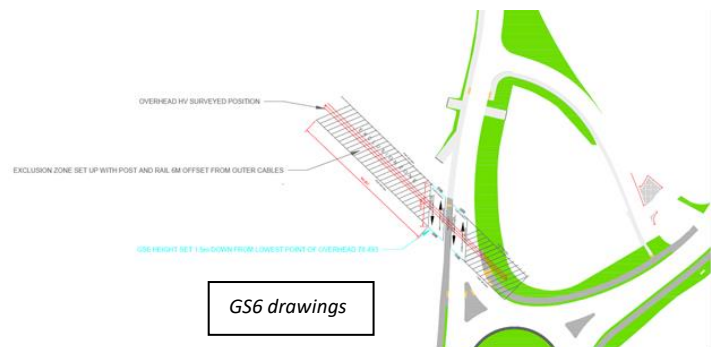
At approximately 3pm on Tuesday 1<sup>st</sup> March 2022, a 20T excavator tracked under an overhead cable, snapping 2 of the 3 cables with its arm.

No work had been planned near the Overhead Cable, on the day of the incident, an excavator and dozer driver changed their location without informing site management. This change took them closer to the overhead powerlines. When moving to go and change the bucket, the arm of the excavator caught the 11kV line.

Scorch marks on excavator arm
