HS₂

Lessons Learned

Lifting Incident: Shutter Panel slid off flatbed trailer - Old Oak Common

Date of incident:	09/05/2023	Incident type:	HiPo Level 2
Incident ref:	INC15602en	Contractor:	Select Plant Hire
Location:	Old Oak Common (BBVS)	Issued by:	James Smith
Keyword Search:	Lifting Incident

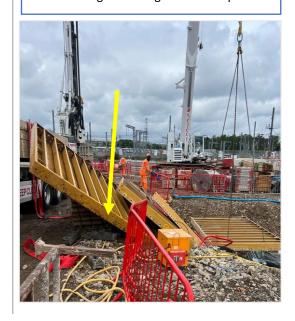
As the driver slewed, it caused the partly slung load to move and slide off the side of the flatbed trailer onto the ground, no injury occurred.

Different angle showing the shutter panels.

- Ensure that a suitable SSOW is in place to compliment the schedule of lifts in terms of tasks that are required to support the lifting activity.
- Written instruction via a task briefing should be in place for safe lifting onto trailers to ensure that there isn't an over reliance on the schedule of common lifts which generally only covers to slinging and lifting requirements.

- Never deviate from the lifting standards including the approved schedule of common lifts. If there is an issue the method, then stop work and report to management.
