Safety Alert

Lifting Incident: Lowered Hook Block

Lifting Incident: Lowered Hook Block – Old Oak Common

Date of incident:	11/05/2023	Incident type:	HiPo Level 1
Incident ref:	INC15626ec	Contractor:	Select Plant Hire
Location:	Old Oak Common (BBVS)	Issued by:	James Smith
Keyword Search:	Lifting Incident

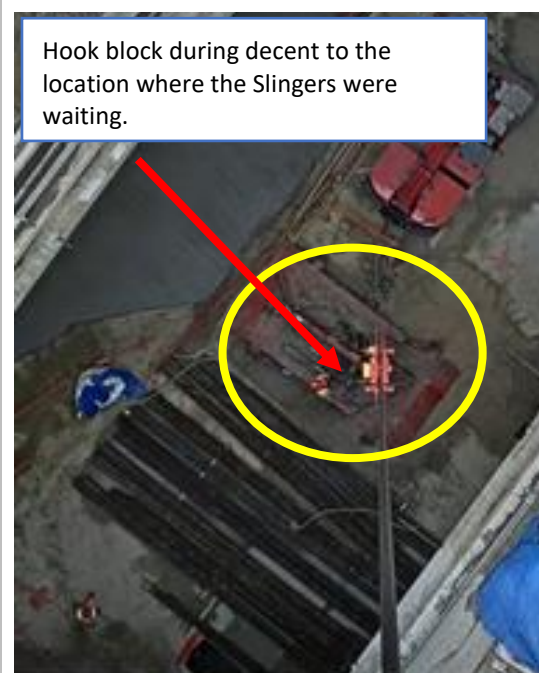
- The hook block was being lowered in 3rd. speed which was deemed to be too fast.
- The visual aids including block cam and speedometer were not used during the lowering of hook block prior to impacting the lifting beam which was situated on the ground.

Hook block during decent to the location where the Slingers were waiting.

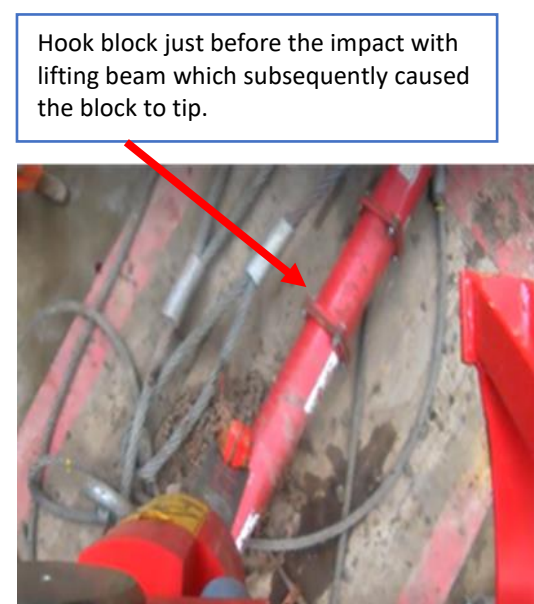
Upon command from the Slinger, the hook block descended towards the lifting beam and didn't stop resulting in hook block striking the spreader bar on the top of the lifting beam, which subsequently rocked to one side.

Hook block just before the impact with lifting beam which subsequently caused the block to tip.
