Safety Alert

VRS Reversing Incident

31 August 2023

Reference number:	012/2023	Date 18/07/2023
Title:	VRS Reversing Incident

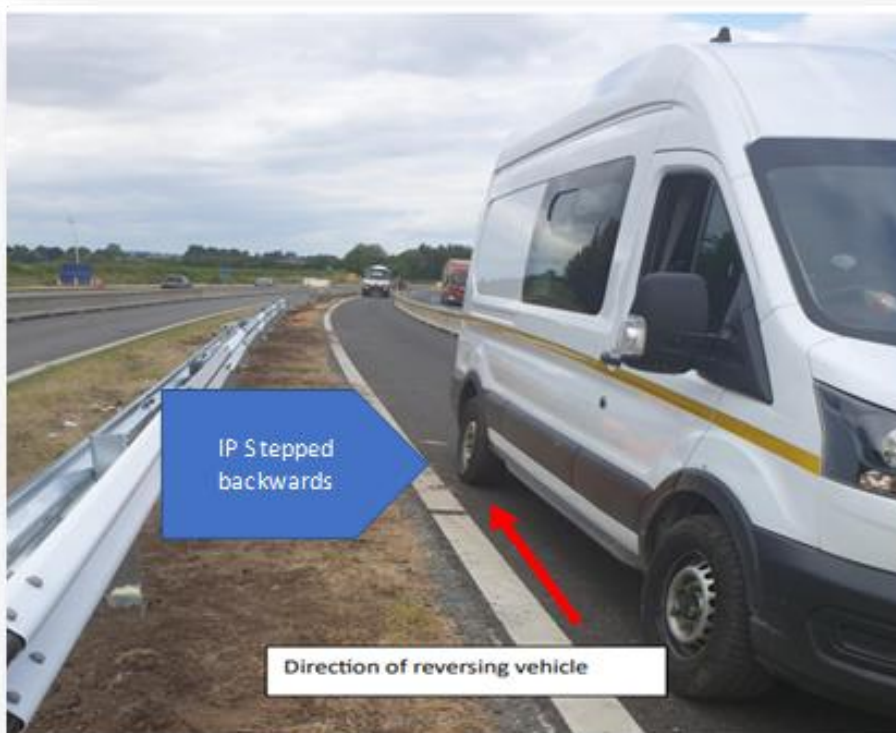
On Friday 23/06/23 at approximately 14:20pm, a VRS operative tightening post bolts on the A1M J56-58 renewal scheme stepped back to check the washer on the bolt he'd just tightened and was struck by a vehicle reversing in the works area. The VRS Operative (IP) sustained a broken leg and was taken to hospital for treatment.
