Safety Alert

M4 Lantern Incident

29 February 2024

Balfour Beatty

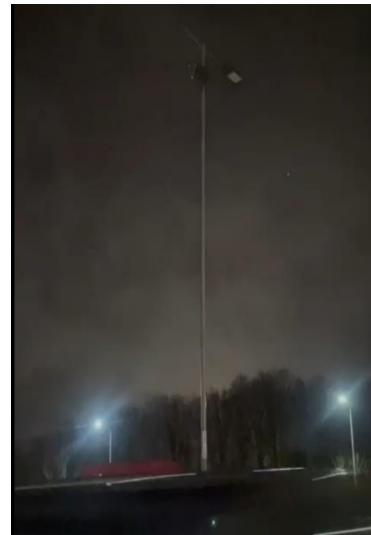
It was reported that on 02/01/2024, a street lighting lantern in the central reserve (lighting column No. 392/008 at M4 J5) became loose from the bracket and was suspended by the lanyard during Storm Henk. The Storm blew the swinging lantern which caused it to strike the column. The highest wind speed was recorded to be 88.9km/h at nearby Heathrow Airport.

Lantern detached and hung by lanyard
During Storm Henk

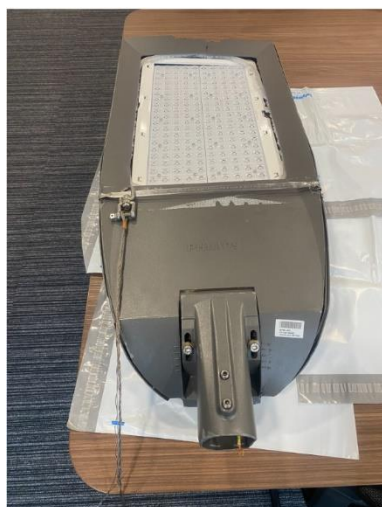
The Area 5 maintainer was called to attend the site. While the Area 5 maintainer (CPS) were waiting for the lane closure to collect the swinging lantern, the lanyard broke, and the lantern fell to the ground at approx. 16:30. No members of the public were affected because of the falling lantern. The lantern was recovered safely.

Fallen Lantern and Spigot

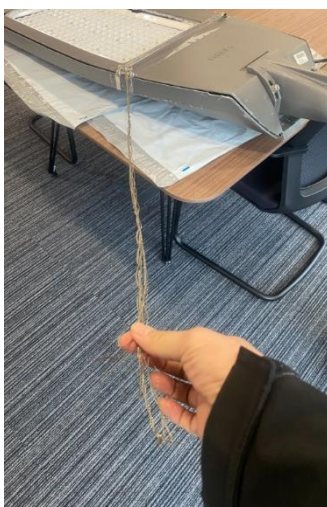
Snapped Lanyard

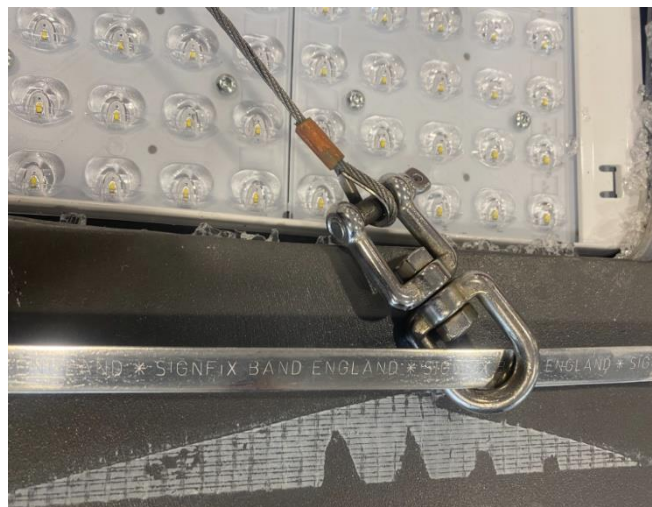
D-Shackle fixing detail

- It is noticed that the locking wires are missing on the D-shackles at all locations.
 - 1no lantern was found to have 1 grub screw spinning in place and the other grub screw torqued to 20Nm

- National Highways SES team is leading an investigation to find the root causes and provide any possible further rectification advice, this is currently ongoing.
- Balfour Beatty Vinci and the specialist lighting installers to inspect all installed lanterns to rectify any identified defects on spigots and lockwires.
