SERIOUS INCIDENT EVENT REVIEW

Incident Description: Load fell from Flatbed when leaving site

Incident Date: 08.12.2020

2600-TDWAY-TTTUN-990-ZZ-PF-700007-P5 ▪ OFFICIAL ▪ Approved Status: Approved

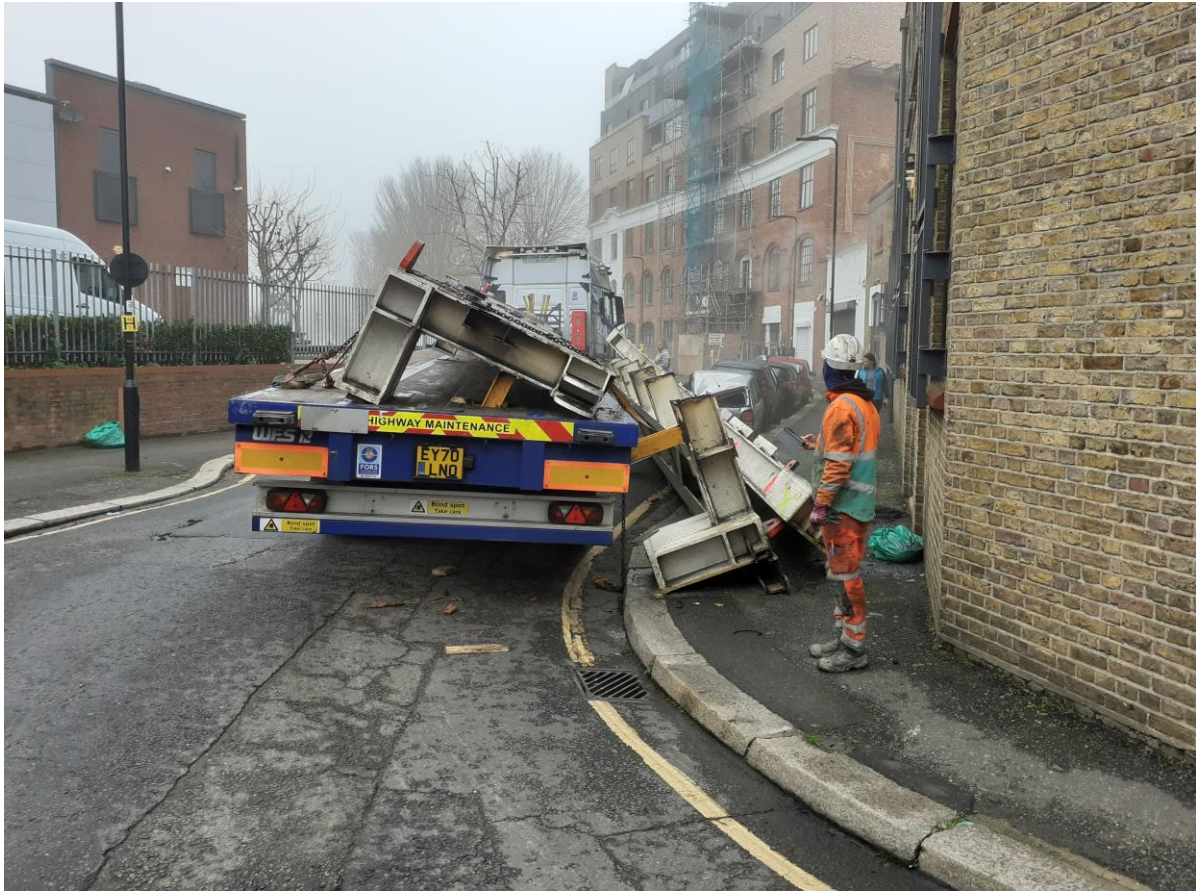
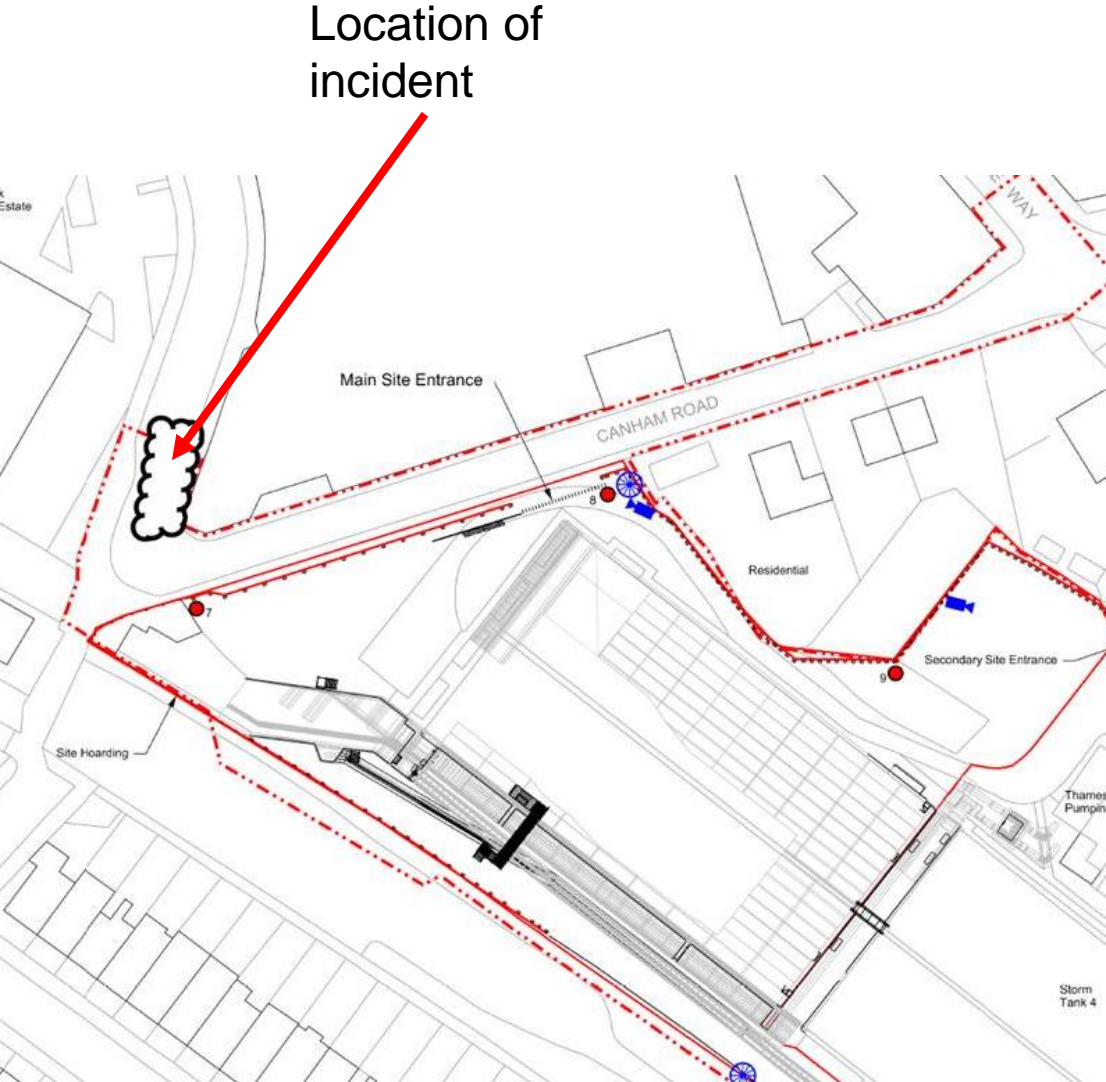
Incident Photographs (As necessary)

- *Load left site at 09:59*
- *Flatbed turned left onto Canham Road*
- *On the first corner turning right the load fell to the right hand side of the Flatbed.*
- *2no legs welded onto the bottom section of the load had punctured through the flat bed.*
- *2no loads fell off the side of the Flatbed, weighing approximately 3T and 2T respectively.*
- *A car and pavement was damaged.*

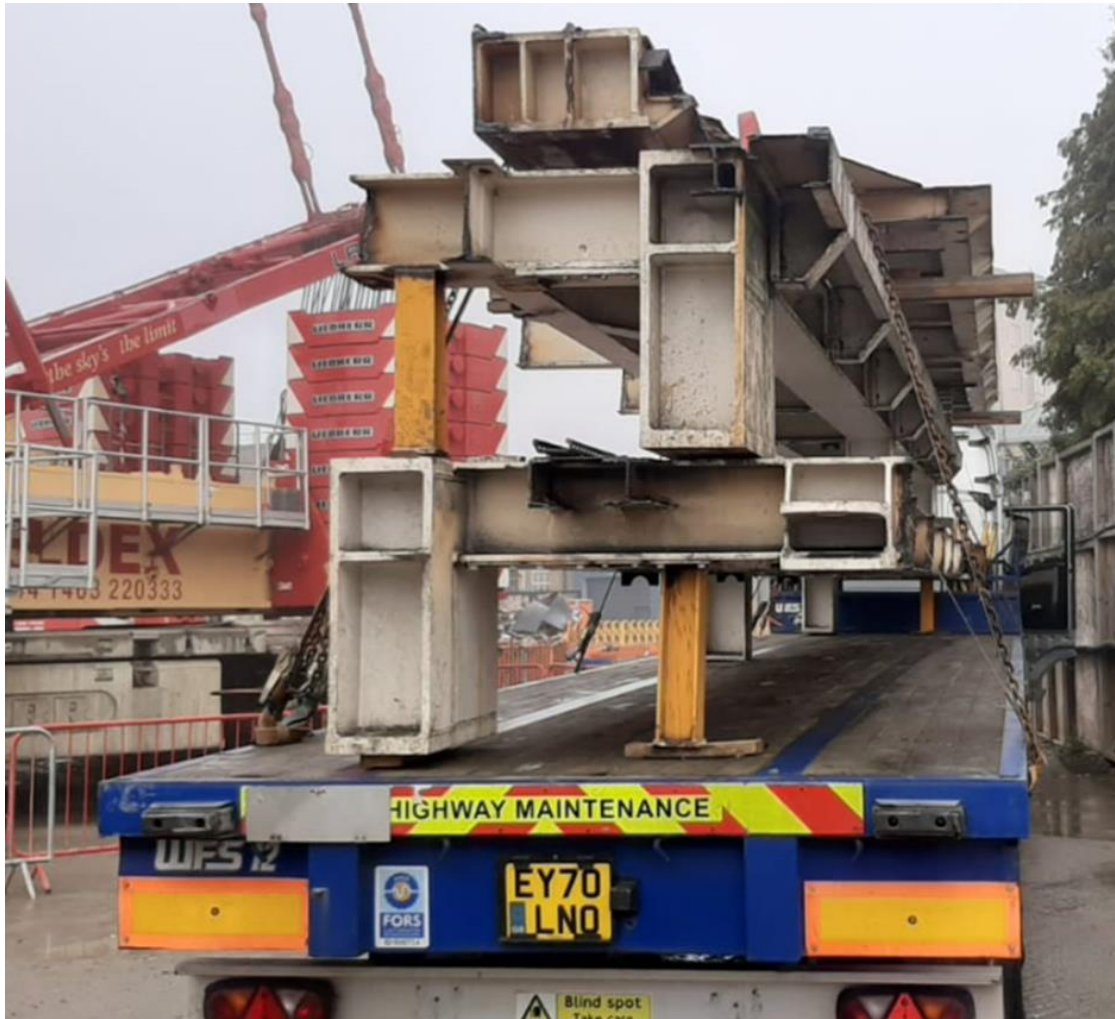
The bottom section of the gantry was supported with 3no large legs on one side and 2no thinner legs on the other.

The 2 thinner legs were placed onto the truck deck with a sections of timber approx. 400mm wide underneath each foot. As can be seen in the photo.

- The height of the stack would not have aided stability. If it was 2 stacks this may not have happened. However this is a “what if”.
- The legs welded on the bottom would have been better suited with wider base plates to spread the load.
- Possibility of wood rot in the flat bed boards may have contributed.

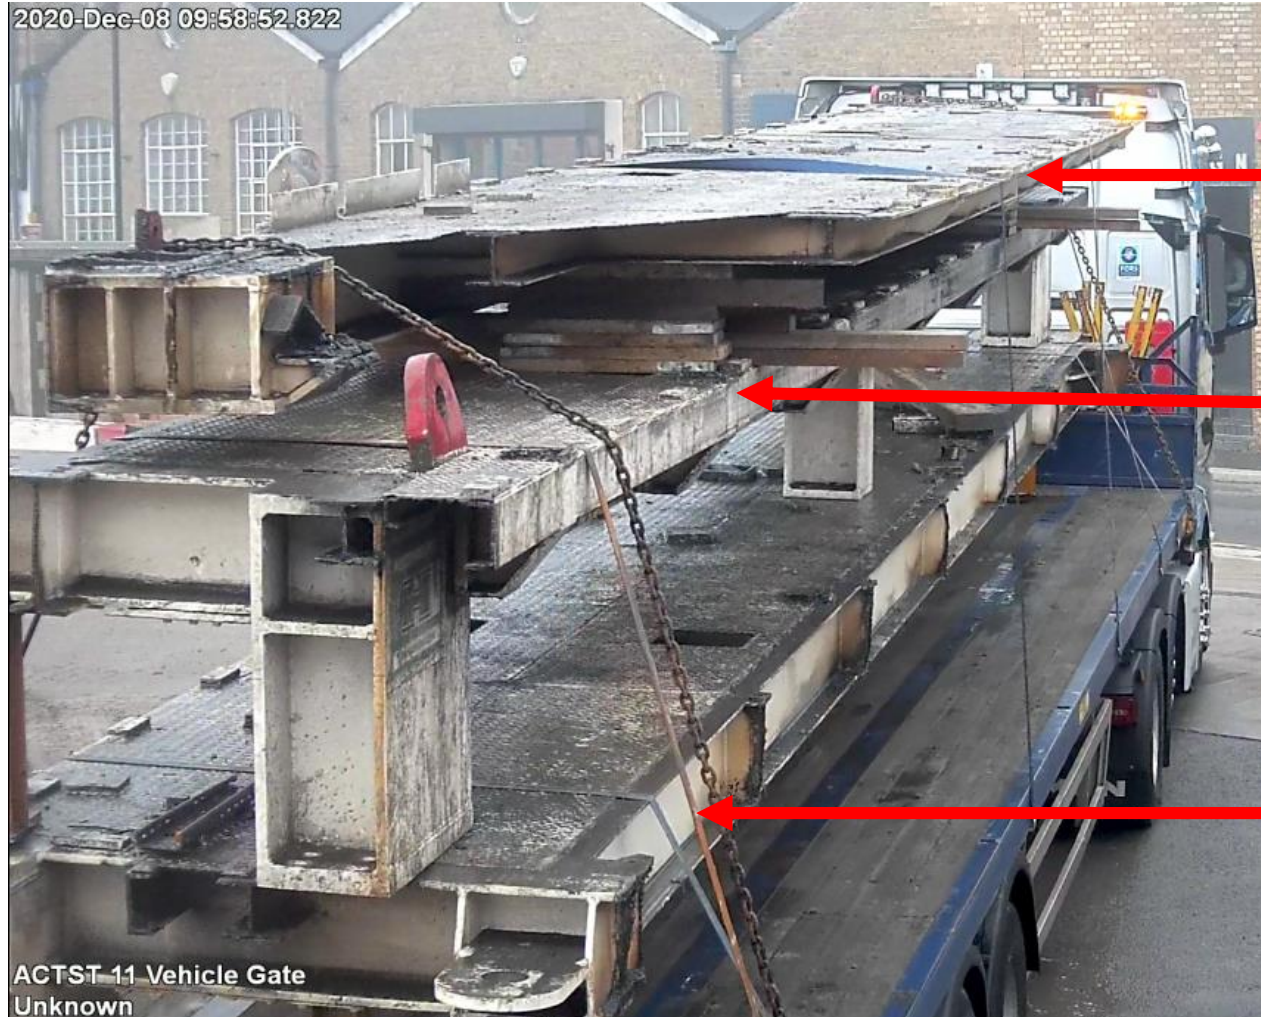
Top section secured using 2no chains and 2no straps. (2T)

Middle section secured using 2no straps (3T)

Lower section secured using 2no straps (5T)

- Hauliers agreed that in this instance the straps were not suitable for the job
- Whilst two sets of chains were used to secure the top piece, the lower and middle sections were only secured by straps. This could have resulted in a shift of weight due to the flexibility of the straps.

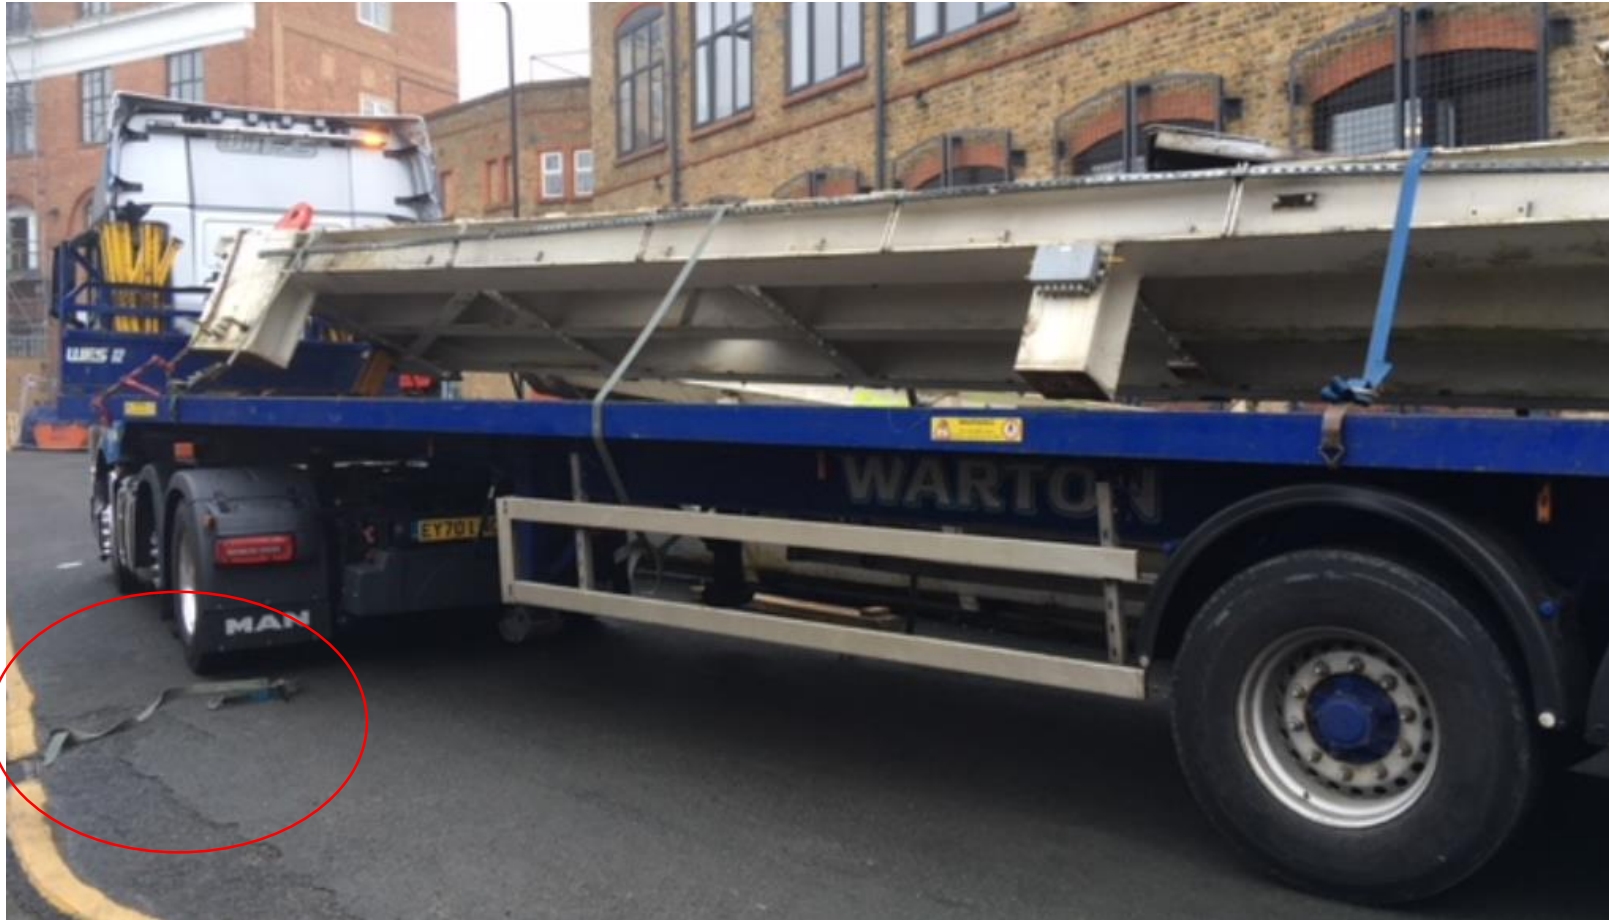
Photo taken at 10:17

Strap snapped

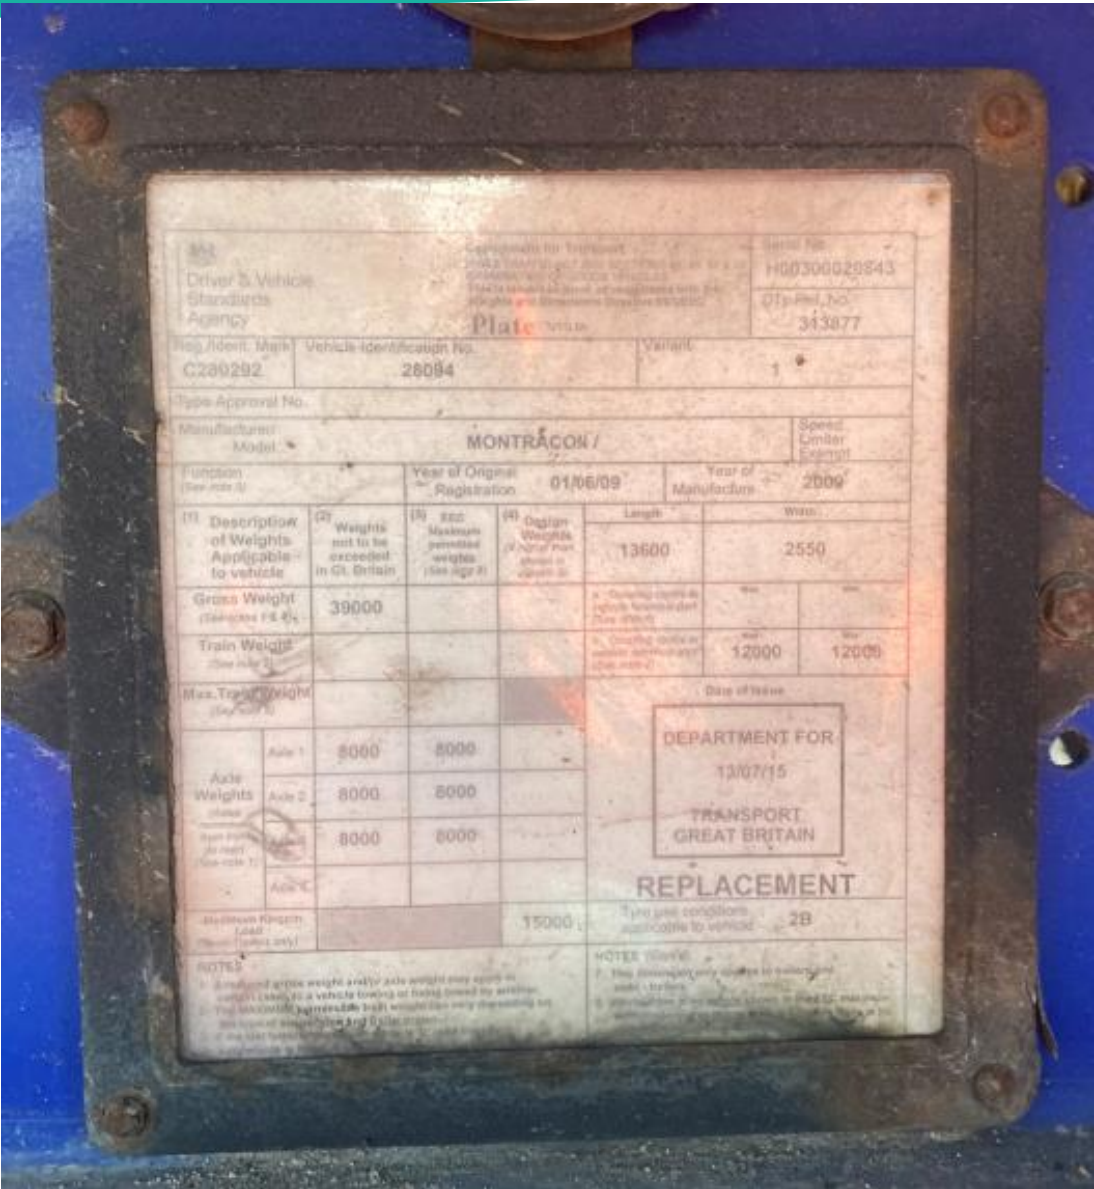
Flatbed:

Max 8T on each axle
Max 15T in total
Registered 2009

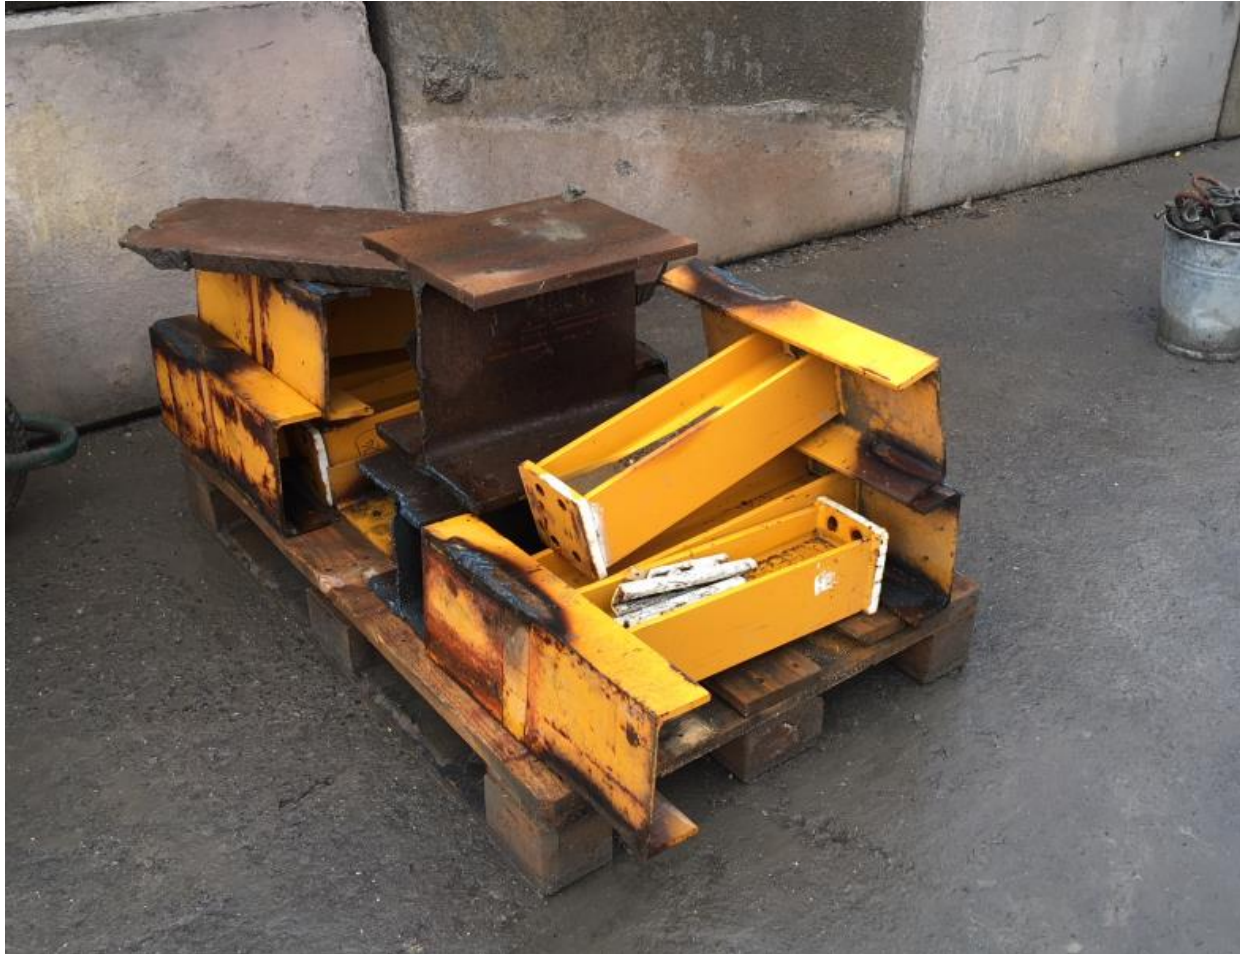
These could have been more suitable to use as legs instead.

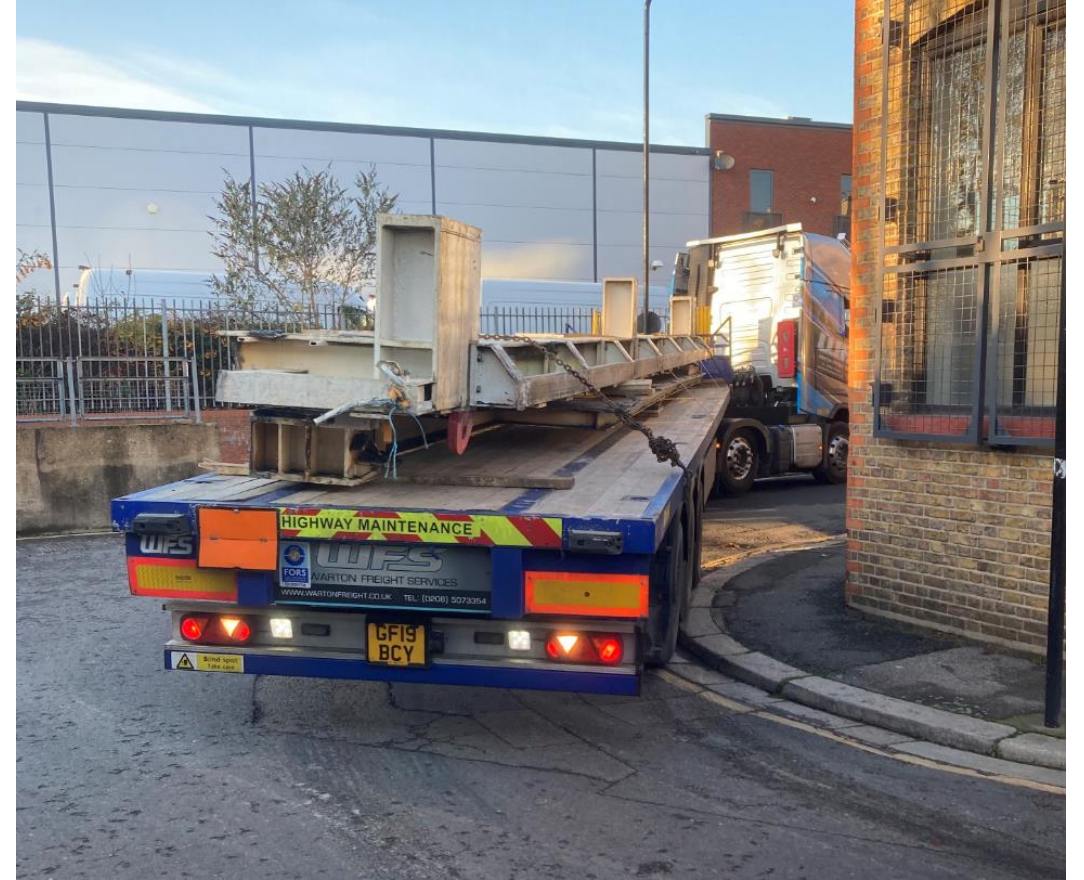
CAMBER IN ROAD

- When the wagon mounted the kerb, this “shock load” caused some part of the loaded stack to shift, also causing the chains to move and potentially loosen.
- When the last wheel came off the kerb, the drop in height with the camber in the road caused the weight to shift, punching through the flat bed.
- Each section should have primarily been with chains and the straps should have protection on.
