# Damage to Culvert – Failure to Identify Underground Assets

WLD.024

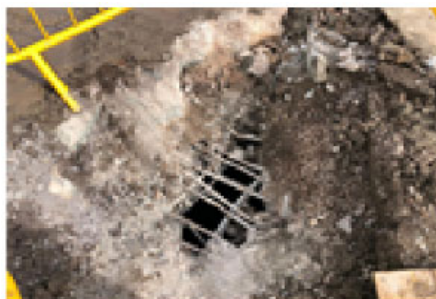
*Existing culvert was damaged due to failure to check records and communicate to the construction team.*

- Damage to an existing culvert exposed workers and MoP to the potential of a structural failure with an assessed residual risk of an almost certain likelihood of serious harm being incurred.
- Failure to review as-built information and carry out on-site survey work, prior to undertaking VCB excavation works in the hard shoulder, resulted in the soffit of a reinforced concrete culvert being extensively damaged.
- The incident was also not reported on HART.

- The culvert's structural integrity was affected with the hard shoulder and adjacent running lane closed for many months leading to extended traffic constraints, delayed works completion and additional costs.
- The lane closures resulted in loss of a haul road and WHS impacts to MoP's due to the extended requirements for TM.

Photo of damaged Culvert soffit

- PD to ensure a PCI gap analysis is undertaken with the client.
- A thorough site inspection and GPR survey should be carried out to PAS 128 A-D.
- Ensure inter-discipline design coordination identifies assets to all disciplines.

- Permit to dig system to be followed at all times.
- Always follow the requirements of GG128 when reporting incidents.
- Contractor to create a digital health and safety file for unusual assets

- Ensure accurate H&S File records are maintained for all buried infrastructure so that there is a clear understanding of where all buried assets are located.

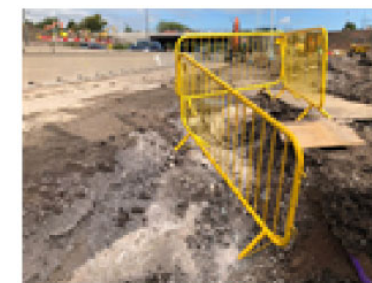
Photo of temporary barriers around the damaged Culvert.
