# PDWG Task Group – Safety Shares

## TECHNOLOGY – TRAFFIC LOOP BOX

## HIGHWAYS – Block Paving

## HIGHWAYS – Flag on Edge

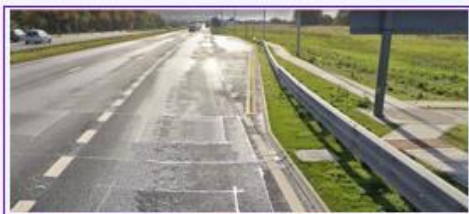
Ref: 1500.001

- Traffic loop box positioned on traffic side of safety barrier resulting in need for full lane traffic management deployment plus layby closure when there is a need to access the box.
- Need for box cover to be strong enough to support 40T HGV for kerb overrun

- Consider how assets will be maintained if they are located on traffic side of vehicle restraint systems, and move to non-vehicle side
- Consider ease of access for maintenance personnel to the chambers or other roadside equipment, and record within Maintenance and Repair Statement
- Ensure maintenance contractors are consulted with during design phase

- Raise observations or queries when product are placed in dangerous locations.
- Check Maintenance and Repair Statement during construction phase

- Raise safety observations with client and request improvement scheme to move roadside hazards into safer locations
- Ensure compliance with [SCSLG Incursions Working Group best practice](#) in TM deployment, maintenance and removal

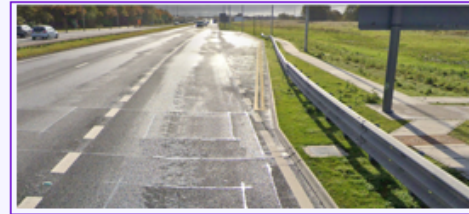
Ref: 1500.001

- A designer has positioned a traffic loop box on live carriageway side of vehicle restraint system.

- Vehicle movement on live carriageway is a hazard to workers maintaining the traffic loop box with an assessed residual risk with an almost certain likelihood of extreme harm being incurred.
- Low load class of cover is a hazard to vehicles traversing the traffic loop box with an assessed residual risk of an unlikely likelihood of minor harm being incurred.

- Provide a safe working area by positioning traffic loop box set back from a suitable vehicle restraint system.
- Provide information and instructions for workers on load class of cover and safe route from maintenance vehicle to working area.

- Submit Request for Clarification to National Highways Project Manager and Raise safety observations when working area around street furniture does not meet National Highways expectations.

- Submit Works Request to provide a safe working area and raise safety observation.
- Design suitable temporary traffic management solution before working on live carriageway.

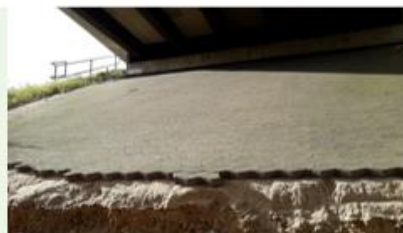
Ref: 700.000

- The A19 Norton to Wynyard project has four bridges with bridge pier extension works. These bridges have block paved revetments which needed to have the first 1 to 2m removed.
- Prior to works commencing, these have been hand removed and, when works were complete, they were been replaced by hand.

The options to replace the revetments with stone slabs or with poured concrete slabs were explored. However, due to the limited areas involved, it was judged acceptable both in cost and carbon saving to remove, store, and replace the blocks.

A three-man team were to remove the blocks manually on an inclined surface prior to works commencing. These were then to be stored on pallets in the main compound until works were complete. The blocks were then to be replaced by hand.

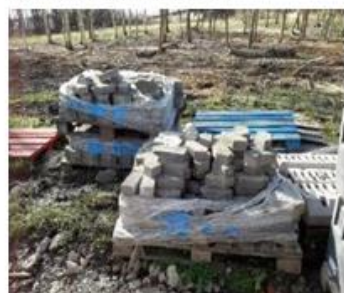
The block paving was removed manually and stored on pallets for each bridge revetment. The pallets were then stored in the main site compound.

Damaged blocks were disposed of as per site policies. The concrete pier extensions were poured. The blocks were brought back on site and hand laid; with a thin concrete strip being cast at the base of some of the piers due to a number of blocks being damaged.

Whilst in this instance the blocks were re-used, is this a good detail? It required considerable manual handling on a steep incline with limited ability to use mechanical plant. The work choice was a consequence of the original design decisions made when the bridge was first built. Designers should do better!

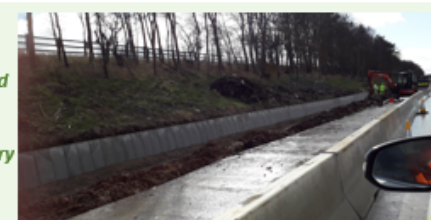
Ref: 700.000

- A19 Norton to Wynyard had a requirement for low height retaining walls along the north and southbound carriageways.
- Over-excavation of the slopes along the A19 posed a significant risk of slope instability during the temporary works phase.
- Flag on edge was utilised as a solution.

Initially various options were considered, with differing material costs, impact on the environment, time /complexity to install, aesthetic appearance, maintenance demands and safety, all being part of the consideration. The flag on edge solution, it was felt involved a minimum temporary works excavation footprint, generating reduced volumes of arisings. Construction was considered to be relatively straightforward and low tech, meaning multiple trades were not all vying to work in the same constrained site area at the same time, and measures could be implemented to mechanise lifting and placing of paving flags as required to minimise manual handling.

Although mechanised lifting was originally specified, with 1000 x 600mm slabs to be used, actual site access restrictions meant that hand installation of the flag on edge was required. Smaller 300 x 600mm slabs were eventually used to reduce the extensive manual handling.

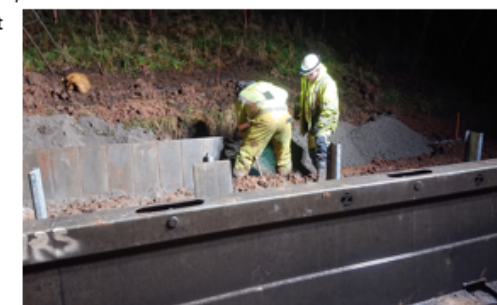
Working area had not been considered during design development. Alternatively, a pre-cast L section, or TCB, could have been substituted for the flag on edge. This could have been placed mechanically and backed up with concrete. There would have been a considerable reduction in manual handling, a reduced duration of the works and consequently this would have limited the exposure of the workforce to injury; and also enabled the TM to have been removed earlier reducing the impact on the travelling public
