PDWG Task Group – Safety Shares

MINIMISING RISKS WHEN VISITING SITE – PLANNING AND PREPARATION

WLD.009

WORKING AREA – INSUFFICIENT WIDTH TO SAFELY UNDERTAKE WORKS

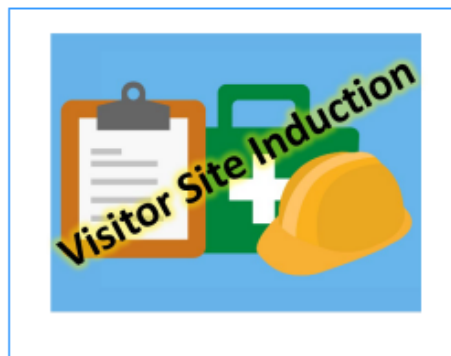
- Inadequate information, instruction, and training provided for site visitors.
- Inadequate supervision of site visitors.
- Breakdown in cooperation between site management and project team.
- Failure of site management team to report to project team change in circumstances on site.
- Worker visiting site unaware of site hazards and associated controls measures with an assessed residual risk of an almost certain likelihood of major harm.

- A site visitor could have been exposed to multiple construction site hazards resulting in reportable injuries.
- Prosecution of client or inadequate arrangements for managing projects.
- Prosecution of principal contractor for lack of suitable site induction and failure to undertake general duties.

- Confirm site management arrangements for visits to site and site inductions are suitable.

- Conduct site visits virtually where possible.
- Provide information on procedure for visits to site.
- Provide instruction and training on procedure for visits to site.
- Prepare site induction and ensure all project team complete site induction.

- Include site visit protocols within Construction Phase Plan.
- Inform project management team when site is open and site is closed.
- Prevent access to construction site by unauthorised persons.
- Visits to site by project team, including designers, must be planned in advance with written acceptance from site management team.

- Raise safety observations.
- Site visitors are to check it is appropriate to visit prior to travelling.
- Travel safety action plans or similar to be in place at all stages of operations.

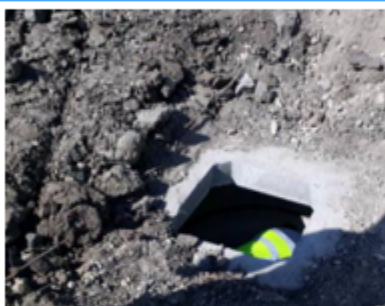
Workers inside inspection chamber that has no safe means of access and no measure to prevent unauthorised entry into confined chamber.

- Access to chamber is via an unstable steep slope of made ground with an assessed risk of likely of serious harm.
- Unauthorised entry into chamber designated as a confined space with an assessed risk of major harm.
- Working adjacent to loose material without adequate means of retention with an assessed risk of almost certain of minor harm.

Photo of uncontained mounded fill beside a manhole which is deemed a confined space.

- Design for external inspection and cleaning.
- Design a safe means of access to inspection chamber.
- Design of inspection chamber's top biscuit to include preinstalled access cover.
- Provide a digital geospatial means to control access to chamber.
- Invert levels to be no greater than 1.2m below finished ground levels.

- Put in place suitable control to prevent unauthorised access to inspection chamber.
- Ensure safe means of access and barriers to work site is provided.
- Ensure site hazards are eliminated, including loose material, before starting work.
- Adopt digital technologies to inform workers of existing site hazards.
- Provide warning signage around existing site hazards.

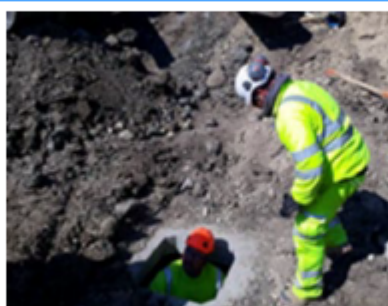
- Slips, trips, falls resulting in reportable injury.
- Loss of consciousness resulting in death.
- Struck by moving material resulting in minor impact and crushing injuries.

Photo of site worker in confined space without the correct precautions.

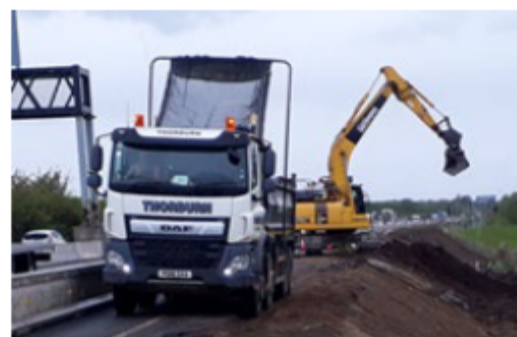
Vehicle operating within barrier safety zone and soft verge edge due to insufficient working width.

- Vehicle driving close to barrier within working width.
- Vehicle operations with nearside wheels on soft ground (verge) has an assessed residual risk of a likely likelihood of major harm.
- Vehicle driving at top of slope with no edge protection.

- Vehicle is at risk of overturning which could result in plant operative and or ground workers in the vicinity being injured.
- VRS will not perform as expected in the event of a collision.
- There is high potential for serious injury due to plant operating within the barrier deflection Safety Zone.
- The residual risks require the working width requirements to be adhered to.

Photo of vehicle within 600mm Safety Zone of VRS barrier.

- Confirm that there is sufficient working width available. If not, potential to request land for temporary works to facilitate additional working area.
- Allowance for barrier Safety Zones and edge protection must be considered at all times.
- Working at night could be considered, to allow increase in extents of lane closures, increasing available working width. Direct and indirect network impacts on safety will need to be factored in, in respect to setting up of the TTM, potential traffic congestion and side road impact.
- BIM and other digital solutions to be used within the design process to check how the size of plant will operate safely within the area.

- Potential provision of edge protection at crest of embankment to ward haulage drivers away from vulnerable edge.
- Identify appropriate working width constraints to the available carriageway and provide it.
- Use alternative plant, e.g., tracked dumpers.
