Principal Designer Working Group

Root Cause Analysis – Capture & Application of Lessons Learnt

Safety Alerts - Recent

National Highways H & S Alerts – Arcadis Summary

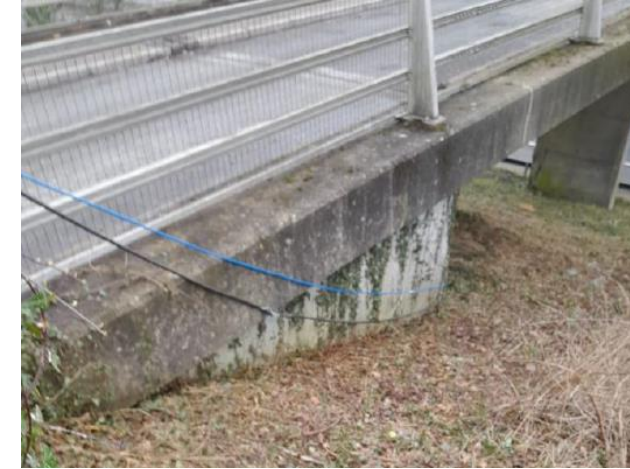
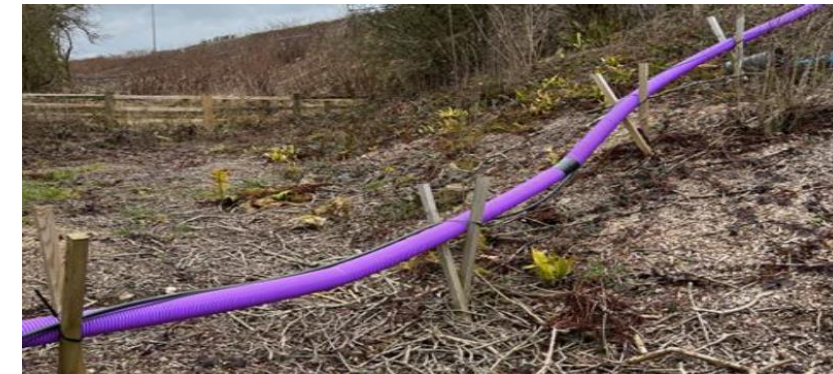
NHa304 – Safe Installation of Surface Laid Cables

- Cables laid in this manner present:
 - A slip / trip hazard to the workforce, and / or members of the public seeking refuge
 - An increased risk of damage leading to;
 - Possible harm to people
 - Loss of essential services such as CCTV monitoring our network
 - A risk of damage to plant & equipment
- Raising the Bar 9 guidance advises that:
 - Temporary surface cables should be sleeved in purple ducting for protection and visibility and;
 - Where possible, that ducting should be raised off the ground using boundary fence lines, stakes etc.
- Cables are often unmarked and are left on site long after schemes are complete.
- RTB 9 says a walkthrough should be undertaken to ensure no legacy hazards are left after the end of a scheme.
