# Lifting Operations

## *Safety Alert*

June 2017

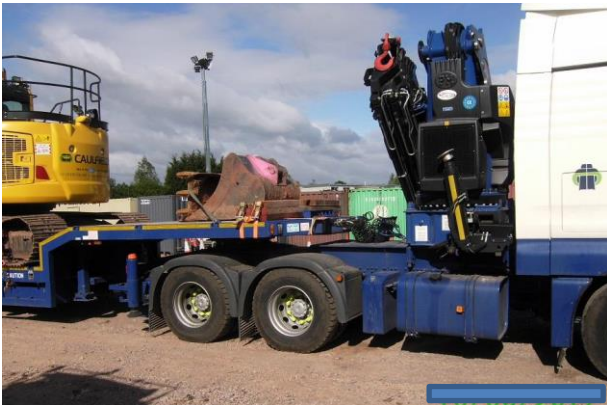
Equipment was being delivered to site using a HIAB (Lorry Mounted Crane) to the verge of a Smart Motorway site.

The HIAB arm was lifting the trench box vertically, when the operator stated that the lifting mechanism 'froze' leaving them unable to operate controls.

It is alleged that during this period, the trench box deviated from its prior position and encroached into 600mm safety zone/vicinity of temporary crash barrier (TCB).

No adverse impacts were reported as a result.

- Review of lift plan for activity to ensure suitability.
- Use of tag lines to guide load.
- Manufacturer inspected HIAB which confirmed there was no issue with functionality.
- Familiarisation training in use of equipment
- Consideration of positioning of vehicle whilst offloading
- Review of working width in area.

- **During planning of lifting operations ensure there is space to allow full extension of stabilising arms.**
- **Lift Plan should be followed and tag lines attached to secure load during transit.**
- **Ensure operator is competent in correct use of lifting equipment.**
