Recovery Operative Injury

Safety Alert

July 2017

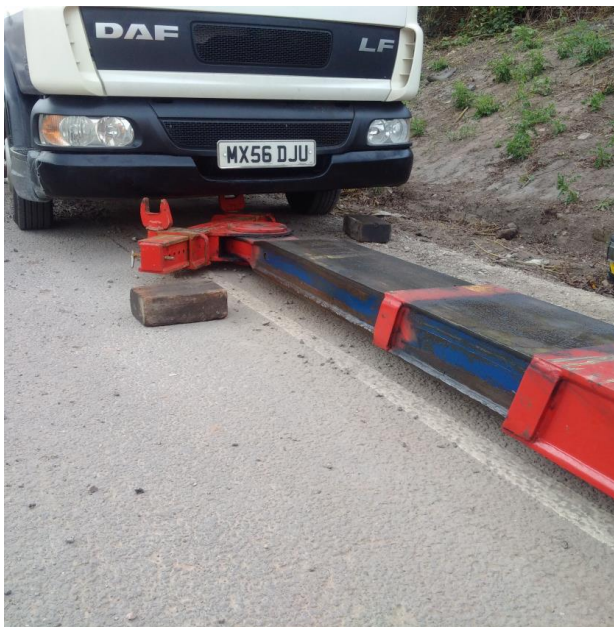
The recovery vehicle had taken the weight of the BDV using a hydraulic vehicle lift attached to the front wheels.

The IP went to apply a clamp and set of chains to the BDV, as they were doing this the BDV dropped striking the IP causing two cuts to his head.

Below – A typical layout of heavy recovery vehicles, hydraulic lifting assembly.

- **Review the pre-lift inspection plan and ensure the following is included:**
- **Confirmation that the vehicle being recovered has its air hand break applied.**
- **Chocks are applied to both rear wheels to prevent the vehicle rolling backwards.**
- **Once the full investigation has been completed we will share any further learning**
