## Traffic Management Operative Incident

### Overview

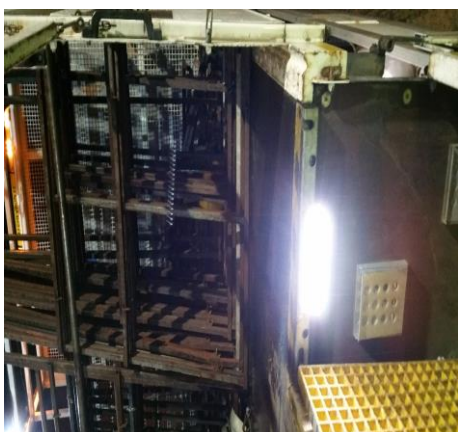
On the 14<sup>th</sup> July, at approximately 2300, a traffic management operative suffered an injury whilst deploying Traffic Management on the M62 west bound at junction 2. The operative was working on the rear of the HGV traffic management vehicle removing a frame from the frame rack on the offside of the vehicle.

As the operative turned with the frame in their hands, they took a step back with their right leg and fell into the cone well sustaining a broken scapula.

Initial findings identified the following contributory factors

- The offside coning well was open as the crew were still in the process of installing the longitudinal run.
- There were a bag of cone lamps restricting the working area.
- The signs had been stowed incorrectly forcing the operative to take the sign out from the opposite side to that normally used.
- Situational Awareness – The operative was focussed on the task in hand i.e. accessing the frames, and a lapse of concentration led to them being unaware of the risk of the opened cone well.

- Traffic Management vehicles to be checked prior to deployment to ensure all equipment is correctly stowed and that all working areas are free from obstructions and tripping hazards.
- The trap door should be closed when the cone well is not being used.
- Operatives should be aware of their surroundings at all times.
- Operatives should stop work immediately if they identify hazards, and make the work area safe before proceeding.
