Incident Description

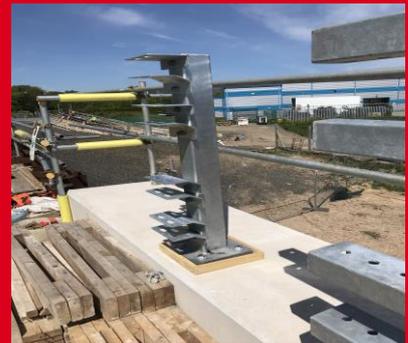
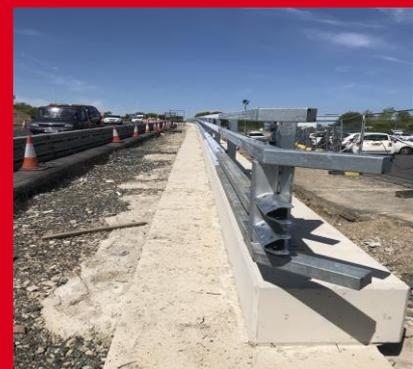
- During an operation to install a steel parapet VRS to a capping beam, a scaffold handrail was removed prior to the parapet being in place, which exposed operatives to an uncontrolled risk of a fall from height of 3.5m.

- Previous safe installation of the VRS had involved using a 'proprietary edge protection' system which allows the parapet to be installed whilst maintaining temporary edge protection. This had not been used in this instance.

- A general operative without any scaffold competence was instructed by the site team to carry out this task.
- The operative commenced the task without the use of a harness resulting in exposure to significant risk of falling from height.

- The operative was stopped before all the guardrail was removed.
- The Works Manager rectified the hand rail using a competent scaffolder.
- Upon investigation it was found that there wasn't a SSOW in place and a member of the site team instructed an untrained person to work at height without suitable edge or fall protection.

- The company procedure to protect our workforce from the working at height risks was circumnavigated to prioritize program and sub-contractor availability.
- The task wasn't risk assessed or any methodology collated to allow this task to proceed.
- The SSOW provided by the Sub contractor wasn't site specific and didn't include working at height as a relevant risk, it is felt that this led to a lack of appreciation of working at height as a significant risk by the site team.
- The supervisor in charge of the works has been retrained in the site work at height expectation and coaching is ongoing.
