Crush injury from a scaffold pole

SafetyAlert

November 2018

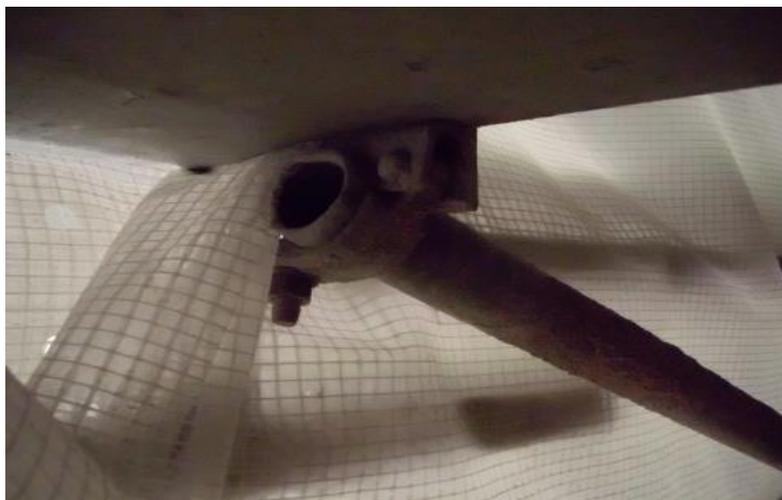
During works to re-configure scaffolding arrangements, an operative was removing a scaffold tube which then moved and trapped two of their fingers. As a result of the injury, the tip of the ring finger on their left hand had to be surgically amputated and a metal rod inserted into the middle finger.

At the time the scaffolder was adjusting the tube and in undoing the coupler, the right-hand end of the tube dropped causing the opposite end of the tube to move upwards, trapping their fingers between the tube and the structure above.

- Brief scaffolding and site teams on the details of this incident & lessons learnt.
- Ensure the scaffolders are instructed to review their structures, and consider how tubes may move when clips are released.
- Consider reviewing scaffolding already on site which use girder clamps and so could create a pinch point.
- Ensure the working area is clear of debris or underfoot hazards.
- If the task being completed is likely to change, a review of the new working method should be completed to reassess the risks and ensure sufficient controls are in place and understood.
- Ensure that when one element of work has been completed, there is a clear process of hand over before another phase of operation begins. In this case, the Hydro Demolition works to the scaffolder team.
