Safety Alert

Broken Gantry Hatch – Area 9

SHE ALERT

Broken Gantry Hatch – Area 9 ASC

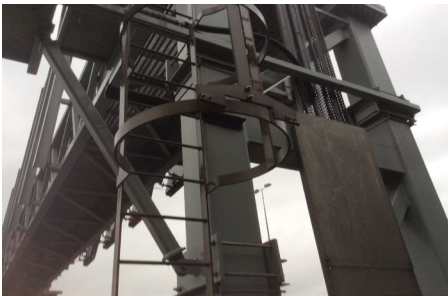
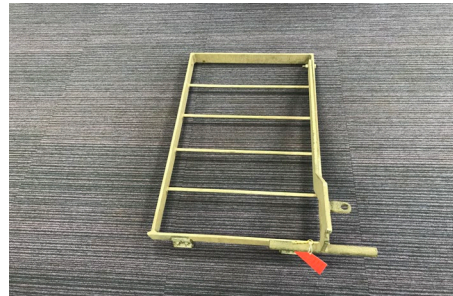
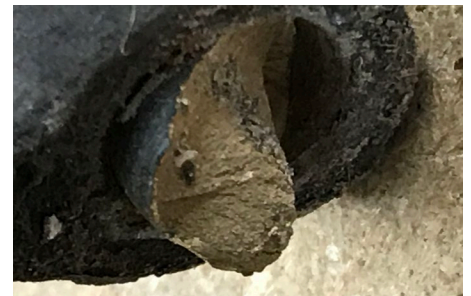
At 14:00 hours on Tuesday 27th November 2018 a steel hatch cover used to block unauthorized access onto gantries failed at its hinge points.

The operative on site reported this fault to his supervisor and the NCC immediately who raised a near miss.

No-one was injured, although this could of lead to a serious incident.

A full investigation is underway and while the root cause of the incident is yet unknown, all investigation findings shall be shared with all, to help staff who may access gantries to be extra vigilant and to help reduce reoccurrence.

- Any personnel accessing fixed ladders and access points, hinges, rungs, grates side rails, locks and keeps must be inspected for any obvious signs of defect prior to accessing above.
- Ensure that no personnel are situated directly below where a component may fall.
- Ensure defects are reported as soon as possible to your supervisor.
- If in any doubt, stop and speak to your Line Manager for further advise.
