Incident Description

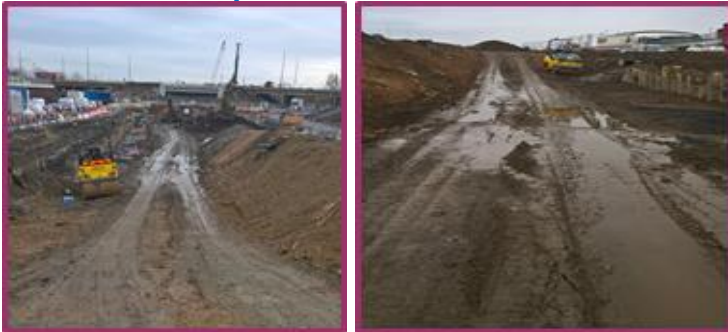
- A sub-contractor was carrying out a programmed operation to break down subsequent piles in preparation for the capping beam installation.
- At break time the three man team were vacating the works area to attend the area welfare unit.

- Two of the team boarded their van whilst the third member of the team decided to walk 250m to the welfare unit.
- As the pedestrian member of the team left the work area, the two team members in the van started to reverse out of the area and as they did they struck the pedestrian team member causing him to fall to the ground.

- The van stopped immediately and the Pedestrian was recovered.
- There were no injuries caused and the Pedestrian immediately returned to work.
- Upon review it was evident that although exclusion zones were established to segregate work areas, pedestrian walkways to segregate vehicles from pedestrians had not been provided in the immediate area.

- All sites should review operations and ensure full exclusion zones are established
- Segregated walkways are installed in areas specifically where plant movements and reversing operations are being carried out
- The rules surrounding the need for Plant Vehicle Marshalls (PVM's) should be clearly established and communicated
