Vacuum Excavator Powerarm Failure

Conforming to Manufacturers Maintenance Requirements.

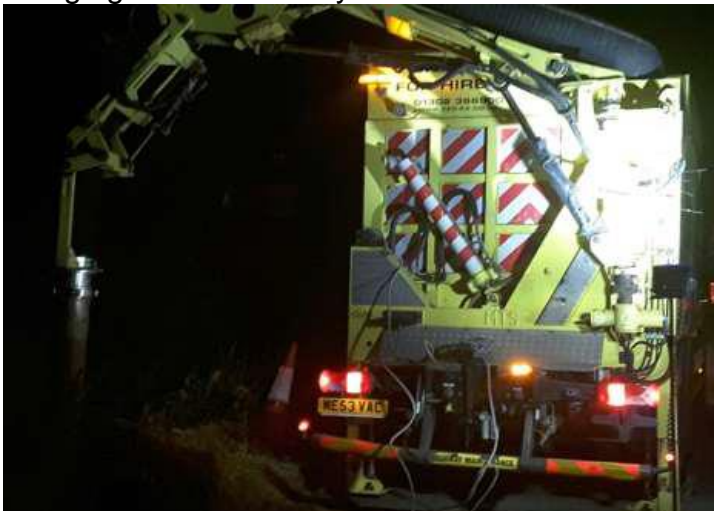
After approx. 1hr 30mins work, 6 of the 8 bolts which connect the arm of the vacuum excavator to the main unit failed, causing the arm to come loose.

The subsequent investigation found that the bolts in question had been in place since the manufacture of the unit in 2008. The manufacturer's service schedule stated that re-tightening of the bolts and screws throughout the 'Powerarm' should be carried out on a monthly basis. This service schedule had not been provided to the suction excavator hire company for the unit. The suction excavation hire company carried out visual daily inspection checks of the equipment. Analysis indicated that the failure of the set screw was due to corrosion fatigue as a result of applied cyclic stress, due to the bolts not being tightened correctly.

Ensure that suction excavator hire companies have the correct manufacturer service schedule for their equipment and are competent to undertake it.

Hire Companies providing a suction excavator, must supply the following for each excavator:

- Evidence of driver competence to use equipment;
- Evidence of second-operator competence to use equipment;
- Copies of driving licences;
- Evidence of daily inspections and PUWER inspections carried out;
- Evidence that they have undertaken and comply with the required maintenance regime for the equipment as per manufacturers requirements for that specific model.
