Issue

Agreed choice of materials and construction methodology between designer and constructor considered primarily the initial construction activity without due consideration of subsequent activities.

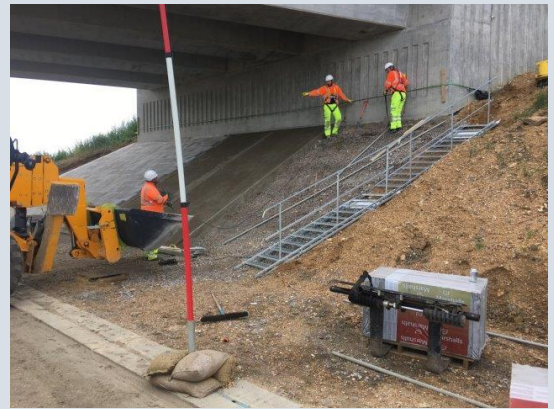
- *Secondary activity to adjust slab bedding did not follow agreed handling methodology*
- *Methodology would be difficult to employ for small scale maintenance works increasing the risk of exposure to a similar hazard.*

Choice of materials and construction methodology failed to prevent a serious injury occurrence when an operative's leg was trapped under a slab whilst installation underway on a bridge revetment.

Agreed material selection and construction methodology between designer and constructor with appropriate assessment of risks and health and safety warnings resulted in unforeseen actions leading to injury. The large precast concrete slab was lifted after laying to readjust levels, not safely stored and toppled onto the operatives leg fracturing a bone.

Consider risks associated with the implied activities resulting from the selection of materials and products throughout the life of the element, including maintenance and decommissioning, as well as the initial construction phase. This should include the feasibility of the assumed construction methodology chosen to mitigate foreseen risks in cases where adjustments may need to be made. Alternative surface treatments which still comply with the design brief should be considered to mitigate risks associated with all whole life activities. Care should also be taken to ensure alternative choices to mitigate risks do not introduce different risks of equal or greater severity.

PC to ensure any agreed methodologies and procedures agreed with the designer and documented within the H&S information provided for construction is followed throughout all related construction activities.

MSP to ensure that all operational activities and maintenance related activities are in accordance with the design risk assessments documentation produced by the design team.
