# ◀ HEALTH & SAFETY ALERT ▶

## Crush Injury Caused by Dropped Load

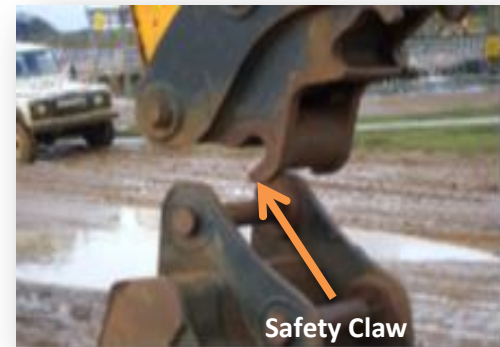
Road plates were moved using an excavator during a drainage laying operation. The last road plate moved was vertically positioned using the safety claw of the quick hitch mechanism; unfortunately an operative was standing in the exclusion zone when the plate slipped and crushed the operative's foot, resulting in the amputation of his toes.

It was found that the road plate was not lifted using the defined lifting point and a drop chain.

The leadership team initiated a safety stand down after the incident. All the workers were reminded about the correct use of plant and equipment.

- Never enter into the exclusion zone around operational plant
- There **must** be a lift plan in place for any lifting operations
- Correct lifting mechanisms and methods **must** be used at all times
- Banksman to be used for people/plant interface
- The safety claw of the quick hitch mechanism **must not** be used for lifting
- If unsure about the correct lifting equipment, ask for advice from a competent person
- Never exceed the operating limits of any piece of lifting equipment
