Safety Alert

Safety Alert 016 – Lifting of Skips by Telehandler

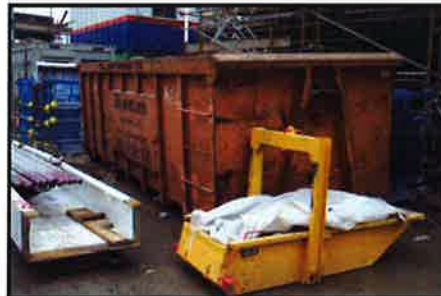
Two incidents have occurred recently at our construction projects whereby the lifting equipment failed whilst in use manoeuvring a large waste skip. The skip (approximate weight 4 tonne) is the high sided skip commonly found on site (pictured here in the background).

- **Telehandlers must not be used on any VINCI project to move this type of skip.**
- Telehandlers are not designed to push / pull skips in this way.
- The forks are designed for vertical loads, not horizontal loads.
- Any movement of these types of skips should be undertaken by the delivery lorry, with its dedicated lifting arm.
- The telehandler, forks or other critical components could become damaged (and not recognised) and could fail on a subsequent lift or at any time in the future.

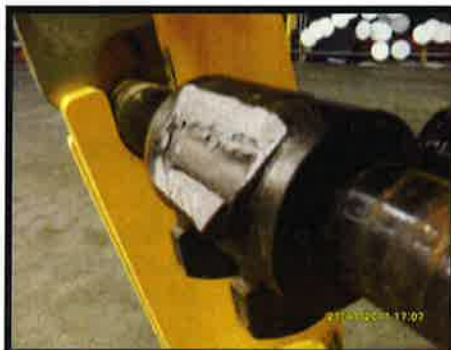
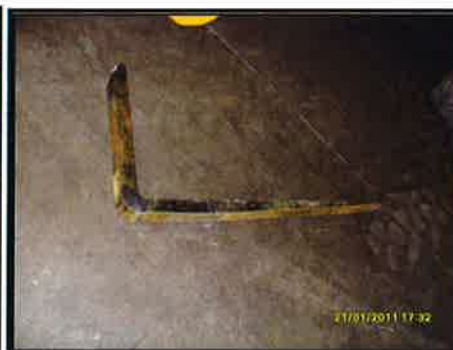
At the time of both incidents the skips were being moved by a telehandler. The telehandler was positioned in front of the skip and lifted one end of the skip. It has then attempted to push the skip using the rollers on the other end to roll it. It is thought that the loads are increased on the forks because they are positioned near to the strengthening beams that run laterally along the base of the skip, therefore tying the forks and not allowing lateral movement

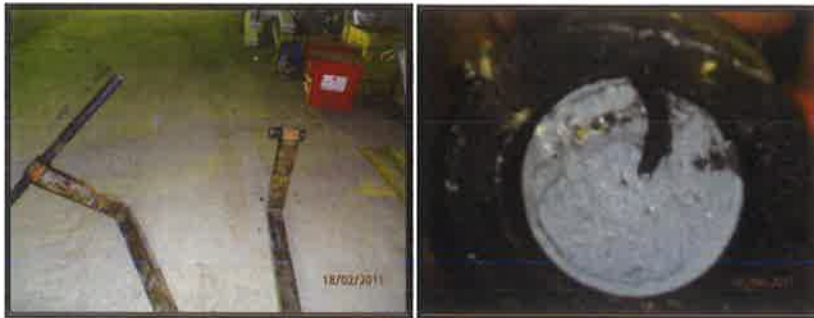
It is believed that both failures have been caused by massive lateral loads being imposed by the action of the vehicle and the pushing of the skip.
