SAFETY ALERT

Security of Cone Well Covers

Issue Date	30 Sep 2015	Issued By:	Matt West
Display Until	31 Oct 2015	Ref. No	SA 029

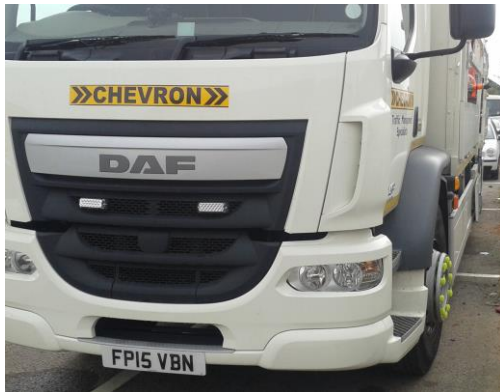
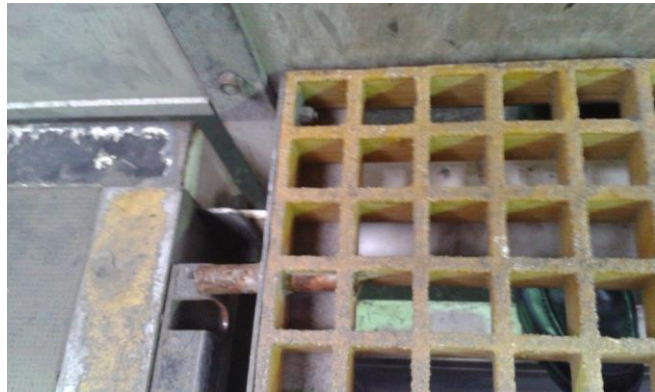
We recently experienced an incident where an operative fell into a cone well whilst loading a stationary IPV, resulting in bruising and minor ligament damage. When the operative accessed the vehicle he believed that the well cover was in place and correctly secured. On investigation it appears that the well cover supports were not correctly located in their retaining slots. The cone well cover was therefore not correctly secured & subsequently dropped into the cone well.

- **Ensure you are familiar with the operation of coning wells and covers prior to commencing work. Remember that different vehicles have different systems fitted.**
- **When working on the bed of a vehicle, loading or unloading vehicles, ensure that well covers are in place and correctly secured.**
- **If you need to remove a cone well cover to access the bed of a vehicle via the cone well, ensure it is replaced correctly prior to commencing work on the bed of the vehicle.**
- **Cone well covers should only be removed for significant periods of time when the cone well is in use for dropping out or picking up cones.**
- **Always use the dedicated, safe access/egress points when accessing or exiting a vehicle.**
