Overtaken ride-on roller

SafetyAlert

December 2017

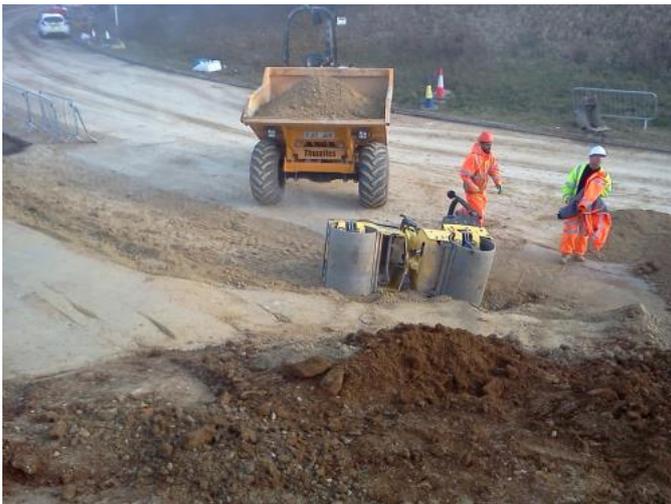
On 10th November, a twin drum, ride-on roller was being used to compact the fill during reinstatement of an embankment in Area 7.

To allow placement of the next layer of fill the operator reversed the roller down the approach ramp where it tipped on to its side.

Although a dedicated, trained operative was on site, at the time of the incident the roller was being operated by an untrained person.

- The keys had been left unsecured
- The agreed method was to keep the roller on the level area while fill was placed.
- The operator was not wearing his seatbelt.
- No-one challenged the operative to verify he was competent to operate the roller.

- **Ensure all operators are suitably trained and competent to use the machinery.**
- **Be prepared to challenge people if you feel their actions are unsafe.**
- **When things change, check that a Safe System of Work is in place and being followed.**
- **Ensure plant is only used in areas that are suitable for that item of plant.**
- **Ensure robust controls are in place to ensure only trained individuals can access plant.**
- **Enforce the use of seat belts.**
