Safety Alert

Missing Inspection Chamber Cover

5th March 2019

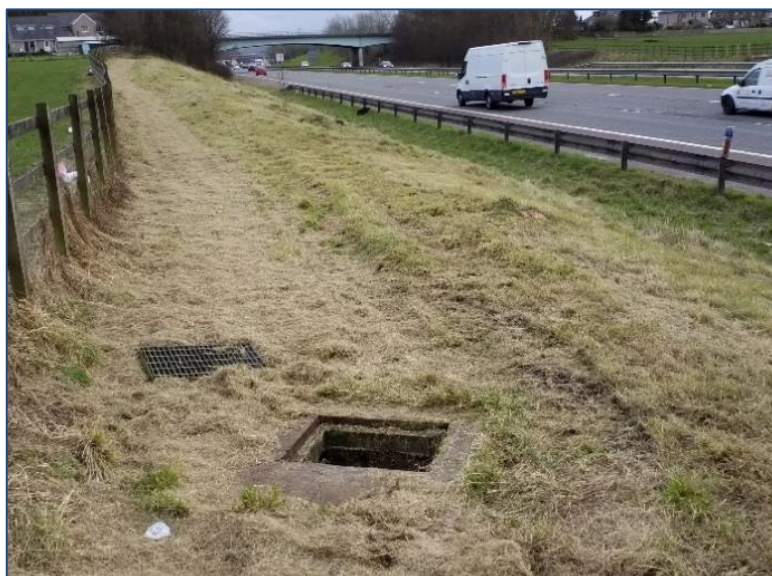
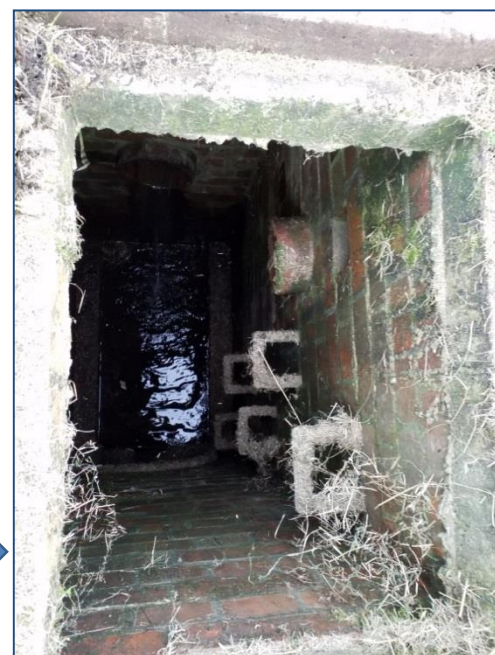
- The Highways England Inspector attended the site and found the hole, an inspection chamber and then eventually found the cover a couple of metres away. He replaced the cover over the hole to make safe. Both the manhole and cover had been hidden by the long grass.

The exposed drop, down the manhole was at least a couple of metres, with metal steps protruding from the walls.

- Whilst manhole/inspection chamber covers should always be in place and secure sometimes they can become damaged or are missing. Always remain vigilant and aware especially where grass is long or natural flora has grown.

- Do not attempt to re-fit a man hole cover if it is heavy and/or you do not have the correct equipment. Note the exact location and report to Maintenance and Response contractor to attend.
