# Safety Alert

## M27 Concrete Pumping Incident

# STOP Think! Moment – M27 Concrete pumping incident adjacent to live carriageway

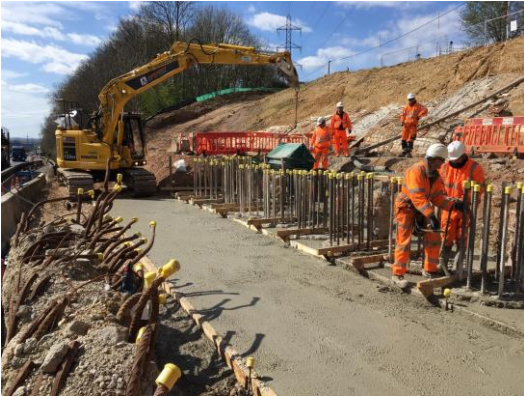
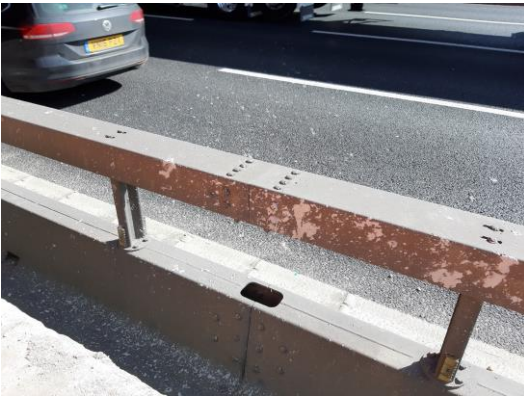
During concrete placement operations an uncontrolled release of concrete occurred and this material was propelled into an area of live traffic.

A 36m concrete pump was set up on top of the motorway embankment with hoses placed down the slope towards the works area to pour the blinding concrete required to form the pile cap. During the work an airlock formed in the discharge hose which subsequently released concrete when the pressure built up from continued pumping. The concrete was ejected from the end of the hose some 10m across the works area toward the live motorway hitting the concrete step barrier and temporary Varioguard which scattered wet concrete across three lanes of traffic.

Airlocks can easily form in the discharge hoses of concrete pumps so care should be taken to ensure there are no kinks in the hoses and that a steady rate of pumping is maintained. Hoses that are laid flat should run parallel to any areas outside of the site boundary and should be shielded.
