Safety Alert

Crane stability

5th June 2019

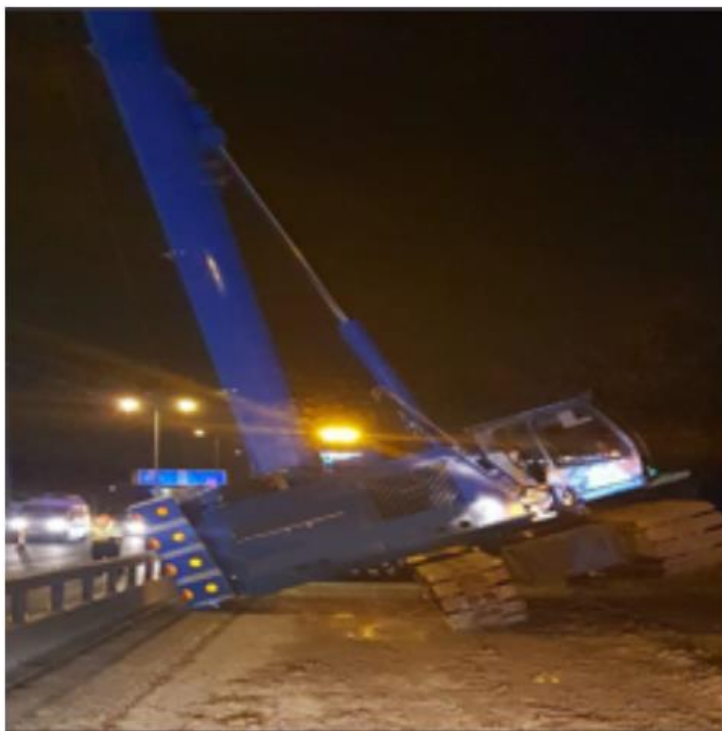
In December 2018 a crawler crane destabilised (shown below) whilst being derigged for transport.

The crane was slewed at 90 degrees whilst the tracks were being brought in. The crane operator was injured as he left the cab. One lane of the motorway was closed before the carriageway was temporarily closed to allow the safe recovery of the crane.

- A slew locking bar, shown above, has been fitted and work instructions revised to require it be fitted and locked in position before the track width is adjusted.
- The crane is then secured in-line with the chassis whilst prepared for transport.
- The crane manufacturer has identified an electro-mechanical solution that prevents the track width being adjusted if the jib is elevated at an angle greater than 20 degrees.

This will prevent the crane de-stabilising. This solution is available as an optional retro-fit circa £3000.
