Safety Alert Excavator Injury

16 March 2020

A14 Excavator Injury

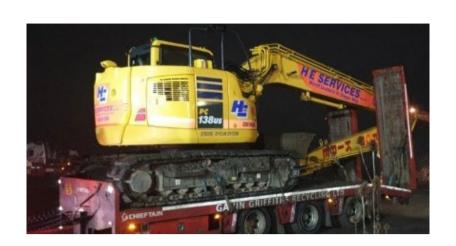
On the 17th of December an operative was injured whilst securing a 14t long reach excavator onto a drag trailer.

The excavator arm hit the operative in the body causing him to fall to ground and sustain injuries to his face. This incident had the potential to cause serious life changing injuries

The method used by both operatives to secure the excavator to the trailer did not follow the Carnell plant, people & vehicle interface rules. This was not raised to their line mangers and both operatives knowingly allowed the excavator to be operated with a person situated within an exclusion zone.

Throughout this operation both operatives maintained visual contact with each other and controlled the excavator movements through various hand signals. Unfortunately the excavator operators coat hooked around the left hand control lever resulting in the arm slewing to the right once the dead man was disengaged. Neither operative considered the accidental movement of the excavator arm.

Risk controls were subsequently reviewed and updated to include requirements to check all control levers prior to starting any plant.

Carnell have mandated the requirement for plant operators to wear 'bomber' style jackets with elasticated cuffs.
