# Safety Alert

## Drilling Rig Safety

16 June 2020

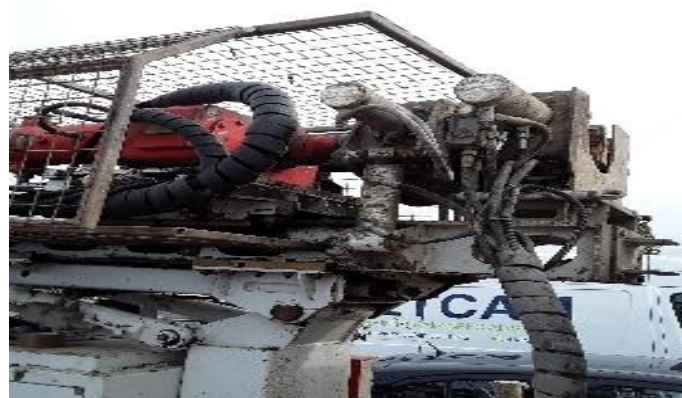
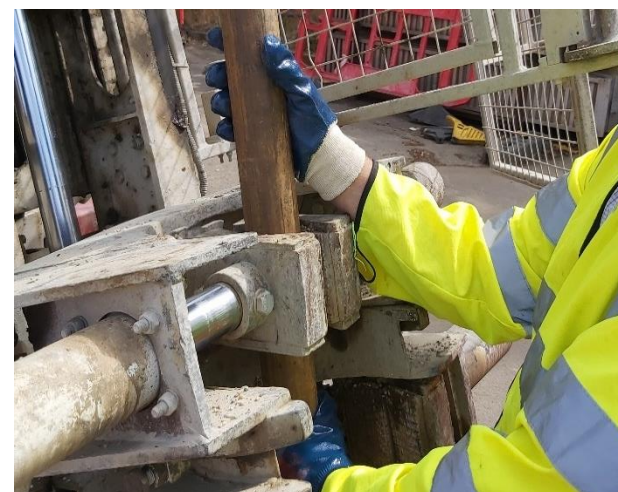
- Geotechnical Engineering were using a Commacchio 305 drilling rig for borehole works.
- The incident occurred when the IP (injured person) was removing the drilling rod from the clamps (*see photo below*)
- The IP took the weight of the rod and the barrel, causing their hand to slip behind the clamp. The IP then instructed the driller to open the clamps which trapped their wrist. The IP sustained two fractures to their wrist and will make a full recovery.

- The correct procedure instructs using a winch on the machine to take the weight of the rod and the operator should guide its movement.
- This procedure was not followed by the operatives, the method they used had become custom practice.
- Video of the incident including interviews by those involved to be produced for wider learning

- Review working practices with drilling rig teams
- A new clamp configuration that covers the gap will be retrofitted to all rigs
- The RAMS are being updated to be more pictorial showing a storyboard of the process.
- All operators within the company have been briefed on the incident using the reconstruction videos

- Highways England's Principal Contractors should review monitoring arrangements to ensure that:
  - Their supply chain are aware of this incident
  - Safe systems of work are being followed
