Safety Alert

Reportable Injury – Lower Thames Crossing Ground Investigation Drilling Operations

12 October 2020

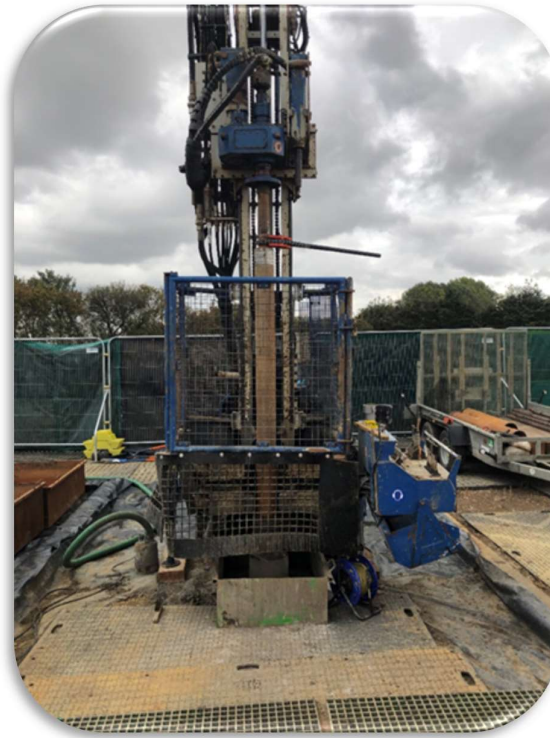
Around 16:30 hrs the drilling crew were finding it difficult to break the last casing from the rotary head with the twin clamps slipping on the casing resulting in polishing. The Lead Driller (fully qualified but newly appointed to the role) suggested that a chain wrench be used to give extra mechanical purchase to the casing, the unplanned / unapproved method being to wrap the chain around the casing, lock the chain off to the wrench handle and wedge the handle against the rig mast above the safety cage in order to provide maximum torque and free up the casings.

As the rig engaged rotation, the torque of the rotation broke the chain away from the wrench handle almost immediately, whipping it around the casing and ejecting it towards the Support Operative striking him on the safety glasses. The impact of the 1kg 650mm long chain caused the Support Operative to stumble backwards and resulted in a facial fracture, whiplash and superficial cuts and grazes.
