# Safety Alert

## CCTV Track bracket near miss

Ref: SHE H185 A 2021  
Issued by: Kier Highways SHE  
Department  
Date: 16/03/2021

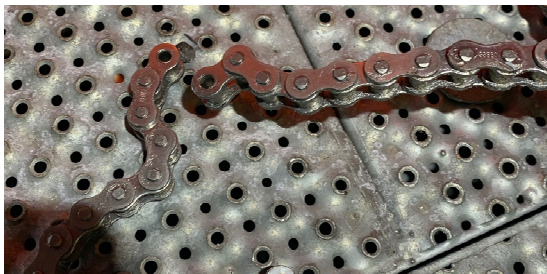
During a night shift installation of a CCTV track-bracket mounted on top of a MS4 gantry, testing was being undertaken on the winch system. During the test, the winch chain failed causing the camera mount (10kg approx.) to fall 4m to the base of the CCTV mast. No injuries occurred but there was significant potential for harm to the installation team.

Photo: Failed chain

Human-error during the off-site assembly process by the manufacturer. Specifically, the spring-clip of one of the split links on the chain was not installed correctly.

Off-site assembly process and procedures revised to include additional checks and sign-offs of the split-links and spring clips.

Mechanical safety clip developed to provide a fail-safe.

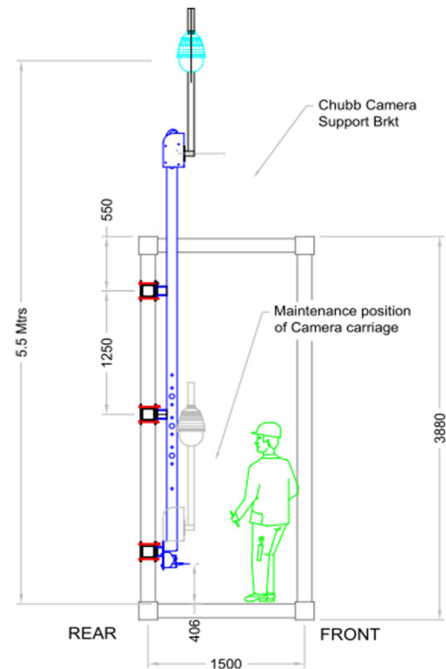
Photo: CCTV mast and track bracket

The clip is installed above head height and would stop the track bracket from passing below that height.

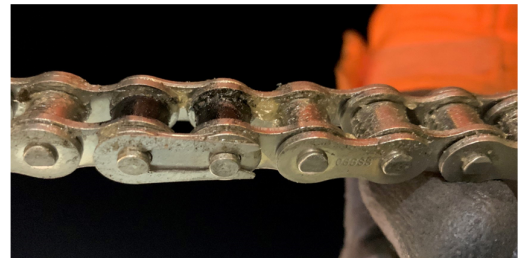
Photo: Correctly installed spring-clip on split-link
