Safety Alert

Drilling Contractor - Lost Time Injury

31 March 2021

Sector	Highways - Transportation	Framework / Contract	RDP North – Scotswood to North Brunton
Date & Time of Incident	17 February 2021	Incident Type	LTI
Location of Incident	A1 Jct 77	Alert Completed by	RDPN SHE Team

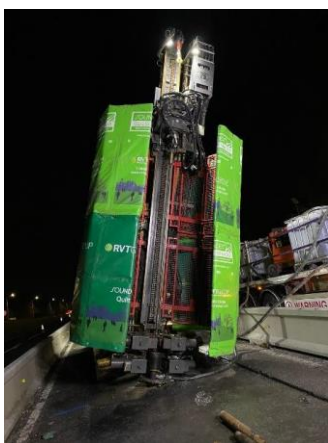
Photo of the drilling rig

Photo not taken at the time of incident

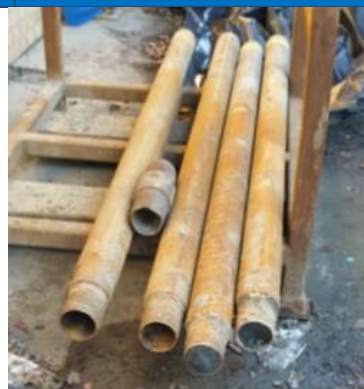
- It is accepted industry practice for an operative to handle casings.
- The risks associated with lifting, handling and carrying of the casings were not identified in the risk assessment.
- The IP had not received suitable manual handling training.

Photo of the casings

2m in length, 110mm diameter and 50kg in weight

- Manual handling risks associated with the casings were overlooked by the RAMS author as well as not identified during the RAMS review process.
- Industry wide lessons learnt include investigating if design changes or machine / equipment changes / additions can be introduced to reduce the manual handling. Drilling contractor are to trial mechanical grab arms at their depot in a safe controlled environment to see if there is a further solution to the reduction of manual handling.
