Safety Alert

Street lighting cable strike

12 April 2021

A30 Crooked Billet– Street Lighting Cable Strike.

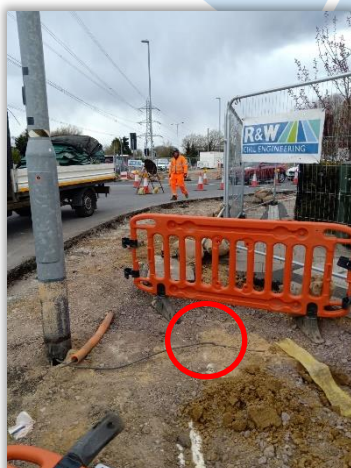
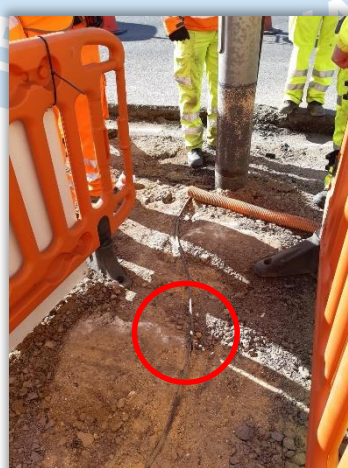
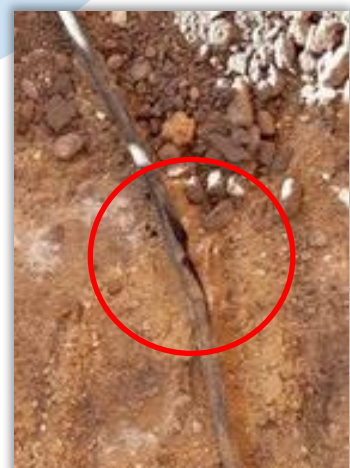
The gang began hand digging to expose the two cables, with the first cable found to be routed through orange ducting and the second one with no form of ducting or warning tape, both cables were found at a shallow depth (200mm deep from finished level).

The ground was very hard which made the hand dig more difficult, during the process an operative using an insulated shovel made contact with the second cable, piercing the outer sheathing which in turn created a small flash.

The gang immediately acknowledged they had damaged the cable and stopped the work, reported the incident to the CPS supervisor, R&W Safety team and to SSE the service owner. SSE came to site and repaired the cable with a safe and secure joint.

- All elements of this task were stopped, and the area segregated.
- Cable Avoidance Tool quarantined, ready for data to be downloaded.
- Incident procedures were followed with relevant parties informed.
- Service provider notified, and assessment and repair requested.
- A full investigation is currently in progress.
