# Safety Alert

### RIDDOR Incident

# SHE ALERT

## Area 13 RIDDOR Incident.

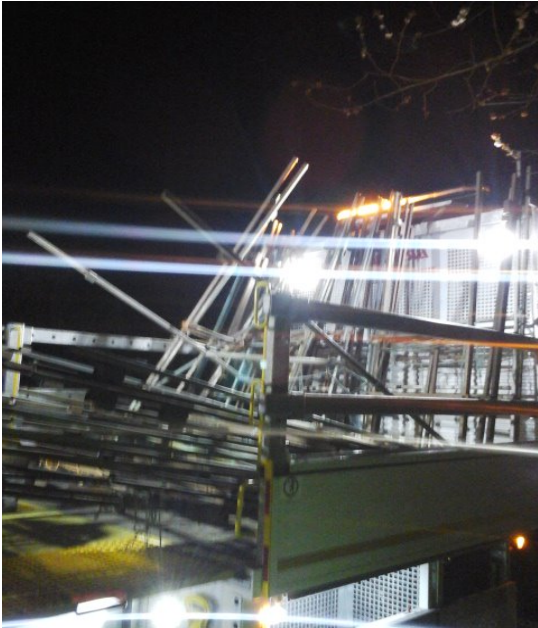
The TM crew were using an 18t TM truck with sign frames loaded against the vehicle headboard. The sign frames were secured with a horizontal steel load restraint bar that slots into holes in the vehicle hand rails.

As the vehicle moved forward a branch over hanging the carriageway caught on the top corner of the sign frames causing the load restraint bar to detach, allowing the sign frames to topple over backwards.

One of the operatives was struck by the sign frame and knocked on to the ground. The rear wheel of the TM truck hit his right foot causing lacerations and abrasion injuries to his foot and ankle. The operative was treated by paramedics at the roadside & taken to hospital where he remains.

TM works that night were suspended and an investigation was launched. Safety stand downs arranged for TM operatives.

- Load restraint bar used to secure the sign frames on the TM truck had potentially failed.
- The vehicle is a 21-plate truck however further investigation is needed into operation and maintenance of the bars across the TM fleets.
- Smaller TM vehicles with lower load bed height would normally be used on this road but these vehicles were off the road for routine maintenance.
- Area not surveyed prior to work in which the overhanging branches could have been identified as a hazard.
