Safety Alert

Corroded Drain Cover

5 May 2021

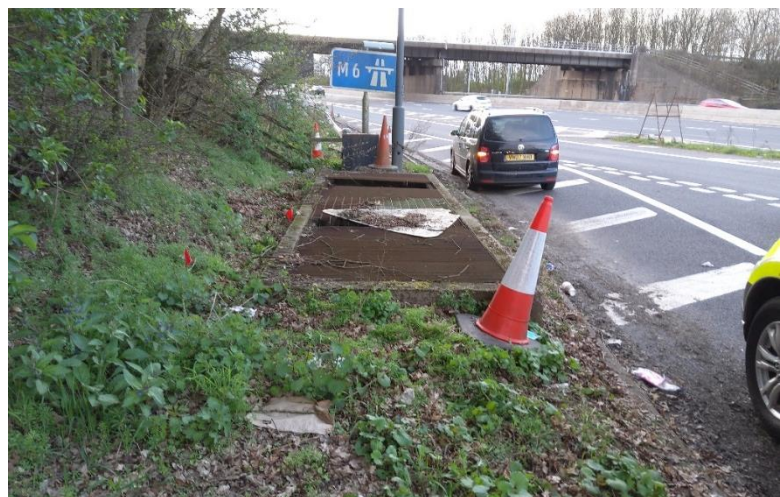
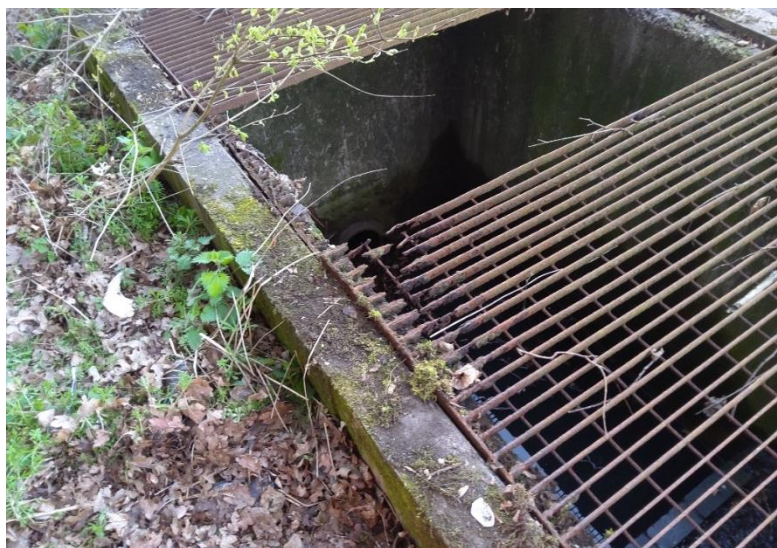
As one of the paramedics walked around the scene, they stood on a metal grate over the top of a catch pit. The metal grating was severely corroded and did not hold the weight of the paramedic, who fell through the grating and into the water below. The paramedic, was helped out by 2 traffic officers who were on scene and taken to hospital for treatment.

The investigation established that the metal grating was not the responsibility of Highways England and that it was the service area owner who had the duty to inspect and maintain it. However, we recognise that we can play a part in ensuring this does not happen again. If you see a drain, manhole, gully or any type of cover or asset that appears to be in a dangerous condition on or near our Network, please report it via the local Regional Operations Centre (ROC) or if you don't know this call the Customer Contact Centre (CCC) on 0300 123 5000 who will liaise with the ROC and arrange for an Inspector to investigate and raise a defect report. We should then contact the asset owner with accurate details of location and condition. If there is confusion over who the asset owner is, HE should instruct the Maintenance & Response contractor to make the area safe and confirm this work has been done.
