Safety Alert

Unsafe position of worker alongside live traffic

12 May 2021

Ref: H193 A 2021 Unsafe position of worker alongside live traffic.
Issued by: Kier Highways SHEA Department
Date: 11/05/2021

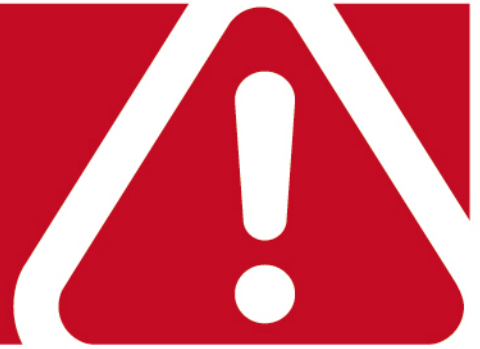
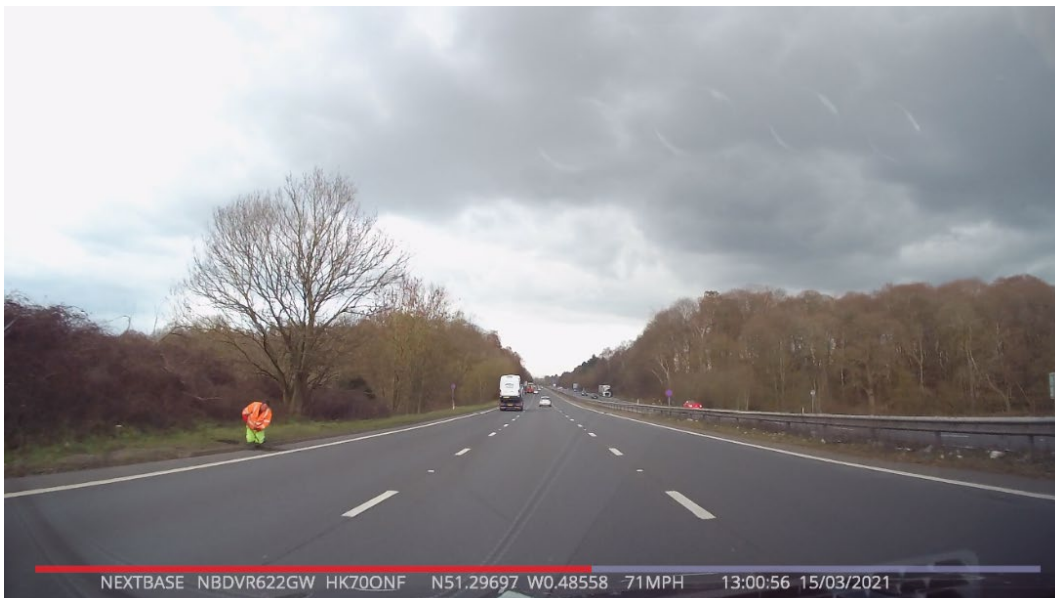
A customer complaint was received in Area 3, providing images from their Dash Cam of a lone worker on the grass verge of the A3, extremely close to live traffic.

The customer shared their concerns surrounding the work practice they'd observed and were worried that no Traffic Management, or safe systems were in place to protect the worker.

"...the operative in question was aware of the operational procedures for working within the 1.2m safety clearance zone, and at the time believed he was observing the required distance from the rib line of the carriageway. In hindsight, he has acknowledged after reviewing the pictures that he may have encroached the 1.2m safety zone by 30cm, but was not in any other contravention of the existing safe system of work..."

To aid our response to this following the investigation, all operational staff must be re-briefed and reminded whilst carrying out short-stop works to;

- always follow the approved Safe System of Work
- stay vigilant, be aware of your surroundings and never cut corners
- carry out a regular dynamic risk assessment and not become task focussed
- follow the Kier 5 SHE basics
