Safety Alert

Tensioned VRS- potential for injury if persons not competent to dismantle

14 June 2021

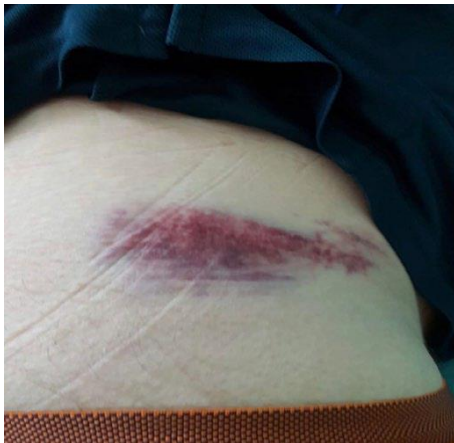
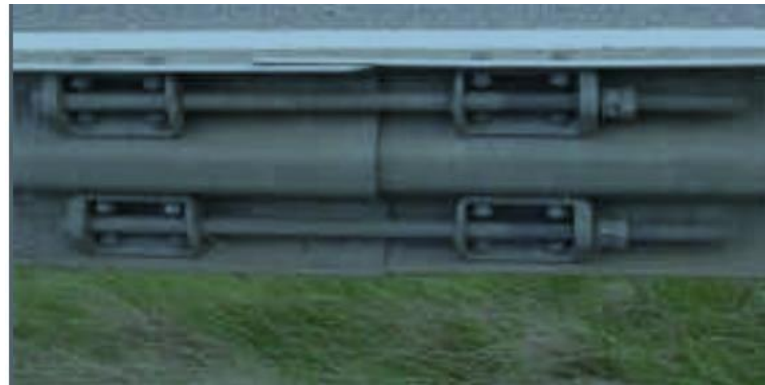
In May, following a Road Traffic Collision (RTC), a Highways England Asset Incident Watchman (AIW) arrived on scene to find the Vehicle Restraint System (VRS) had been dismantled by a vehicle recovery operator. This had been undertaken to aid the recovery of a 3rd party HGV that had collided with and damaged the VRS. No injury occurred, however there was the potential for serious injury as the section of VRS dismantled was a tensioned corrugated beam type, meaning by design it is post-tensioned. Tensioned VRS contains stored energy and must only be dismantled by competent and trained persons.

In late 2019 a Kier operative working on damaged VRS in Area 3 sustained significant bruising, when they were struck by a VRS barrier that had an unexpected release of stored energy.

- VRS should only be worked on by a trained competent member of the service provider's VRS team, with a suitable safe system of work.
- Emergency services have been given advice on how to dismantle tensioned VRS in a life and death scenario.
- Please continue to report safety observations, near misses and incidents.
- Share this bulletin with relevant teams, suppliers and vehicle recovery operators.
- Challenge / report unauthorised VRS alterations when and where safe to do so.
