Safety Alert

Faulty DNO Cabinet

24 June 2021

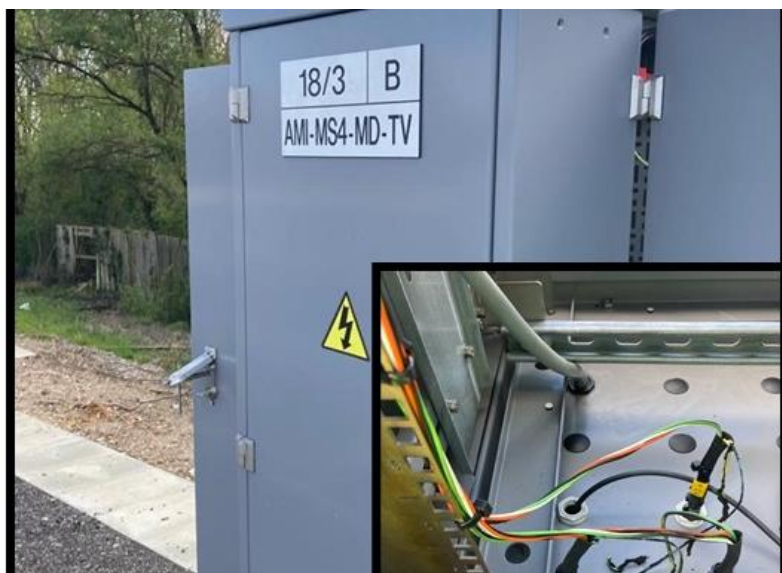
On 15 April 2021 during a planned visit by a BMJV sub-contractors, it was identified that a 600c electrical cabinet was faulty with heat and burn damage to cables, which in turn, was sending 240v through the outside cabinet.

The investigation found the electrical interface unit, situated on the project boundary was faulty and the neutral conductor had become live.

This fault led to the external cabinet being live to 240 volts.

Further checks were made and identified that, the incoming DNO (Distribution Network Operator) supply cables were both live and neutral conductors were both carrying a supply voltage.

- A Non-Contact voltage detector should be used to check if the shell of the metal cabinet is live
- Once satisfied that the cabinet is not live, open the doors and remove the covers to the MCX0164 box
- Using an approved voltage tester and proving unit; check polarity and voltage present on the correct conductors
- Close up covers and doors
- Record and leave site
