<b>Form Ref:</b> HSI-10	<b>Independent Health &amp; Safety Inspection – Blue Star Item</b>	<b>Version: 2.0</b> Jun 2015
----------------------------	--	---------------------------------

<b>Project</b>	<b>Principal Contractor (PC)</b>	<b>Date of Inspection</b>
M1 J19-16	Costain Galliford Try	15/09/16
<b>Site Contact</b>	<b>Email Address</b>	<b>Telephone Number</b>
Eamonn Slevin	<a href="mailto:Eamonn.slevin@costain.com">Eamonn.slevin@costain.com</a>	01788 520600

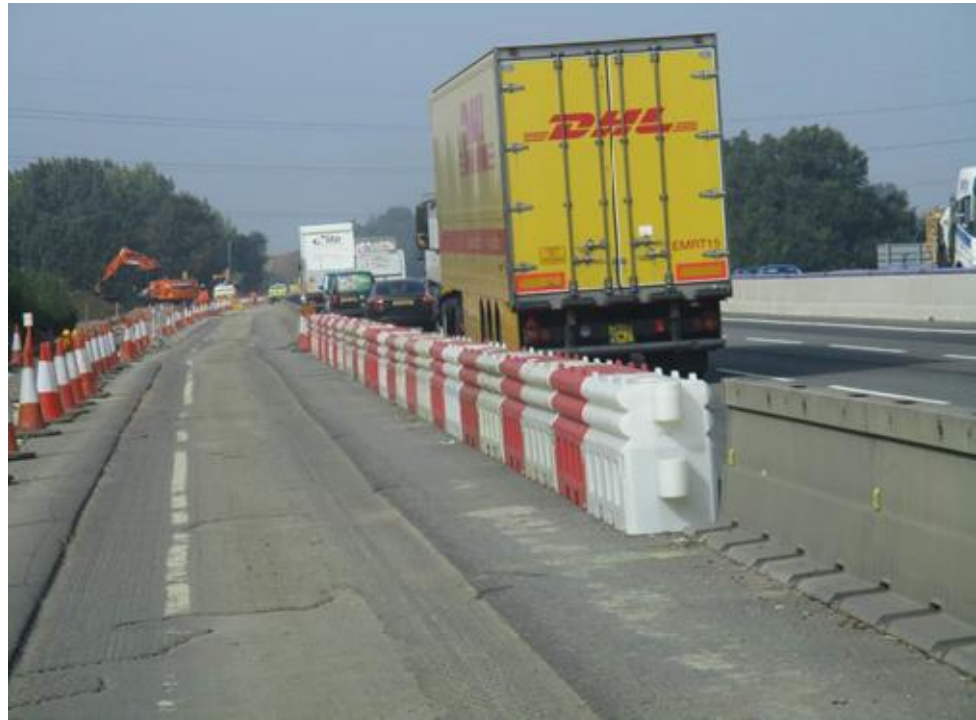
<b>Description of Blue Star Item</b>	<p>The M1 J19-16 contract implements a procedure whereby in order to work adjacent to the live traffic or across an open gap in the Zoneguard, there must be a physical barrier (temporary or permanent) in place or a closed lane separation in place.</p> <p>The picture to the right shows a gap in the Zoneguard filled with water filled barriers (Rhino).</p>
<b>Benefits of Blue Star Item</b>	<p>This system means a lower risk of vehicle incursions into the work site and is safer for the road worker.</p>
<b>Details and Cost of any Specific Product</b>

Gap in the Zoneguard filled with water filled barriers (Rhino)

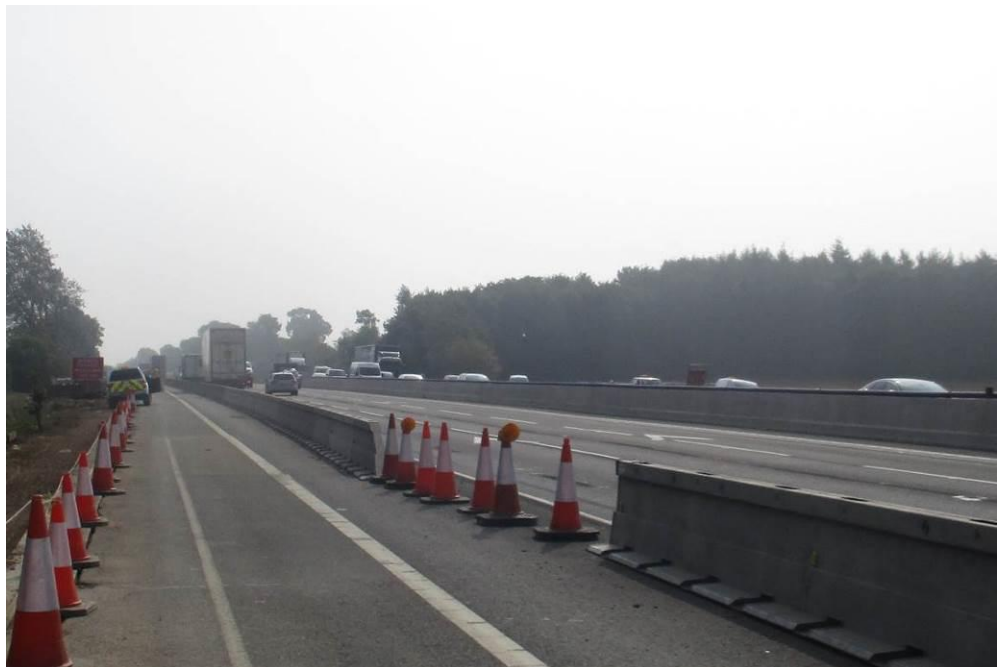
Additional sections of Zoneguard installed to infill access / exit to allow work to take place
